REPORT NO. TR-P27004-09-NC

SAFETY COMPLIANCE TESTING FOR FMVSS 223
REAR IMPACT GUARDS

2007 TRANSFREIGHT TECHNOLOGY

NHTSA NO. RIG 009

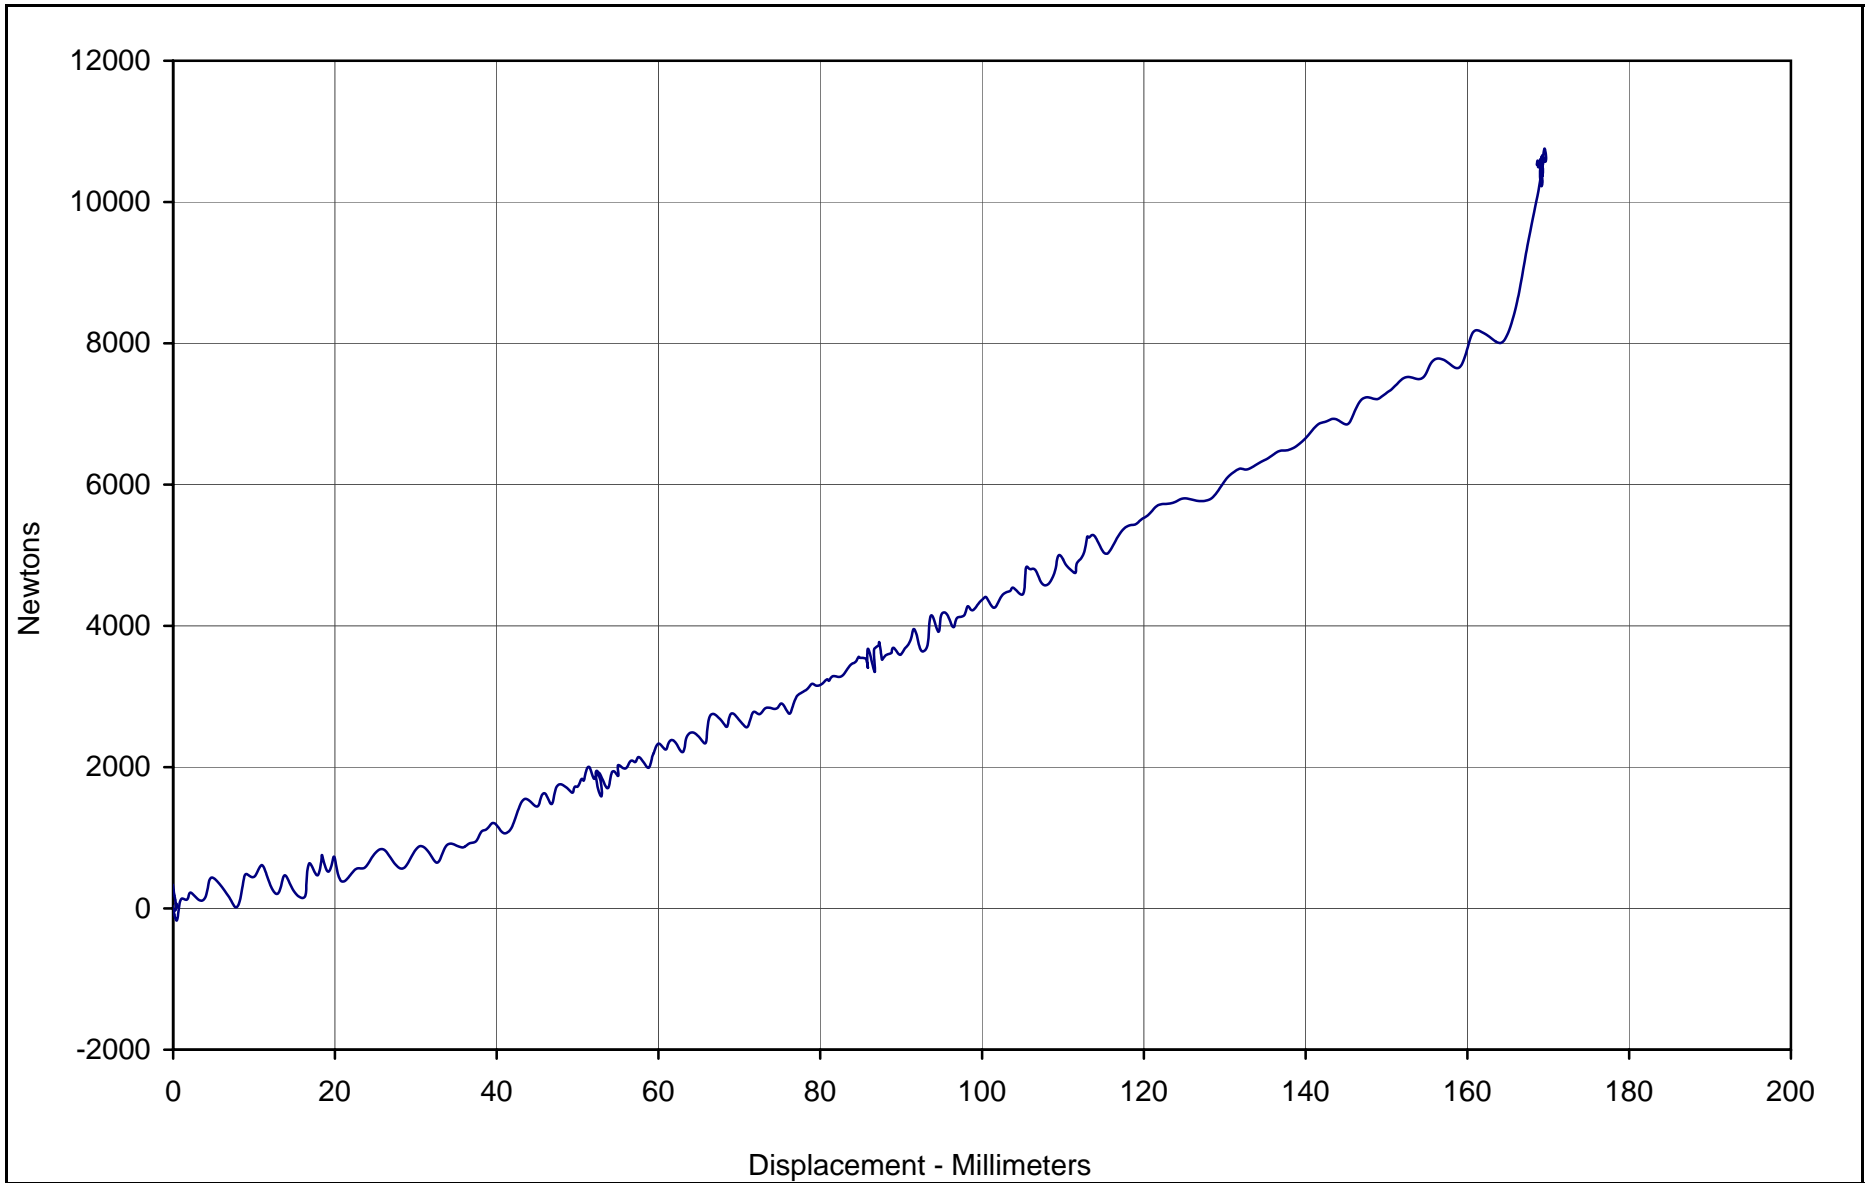
FMVSS 223 REAR IMPACT GUARD (PRE-TEST)

Trailer Guard Description	Test Date	Test Location	Curve Description	Sample Number	Maximum Load (N)	Displacements (mm)	
						At 47.5kN	At Max.
2007 TransFreight Technology	9/7/07	P1 Left Side	Force vs. Displ.	01	10,755	N/A	169.5

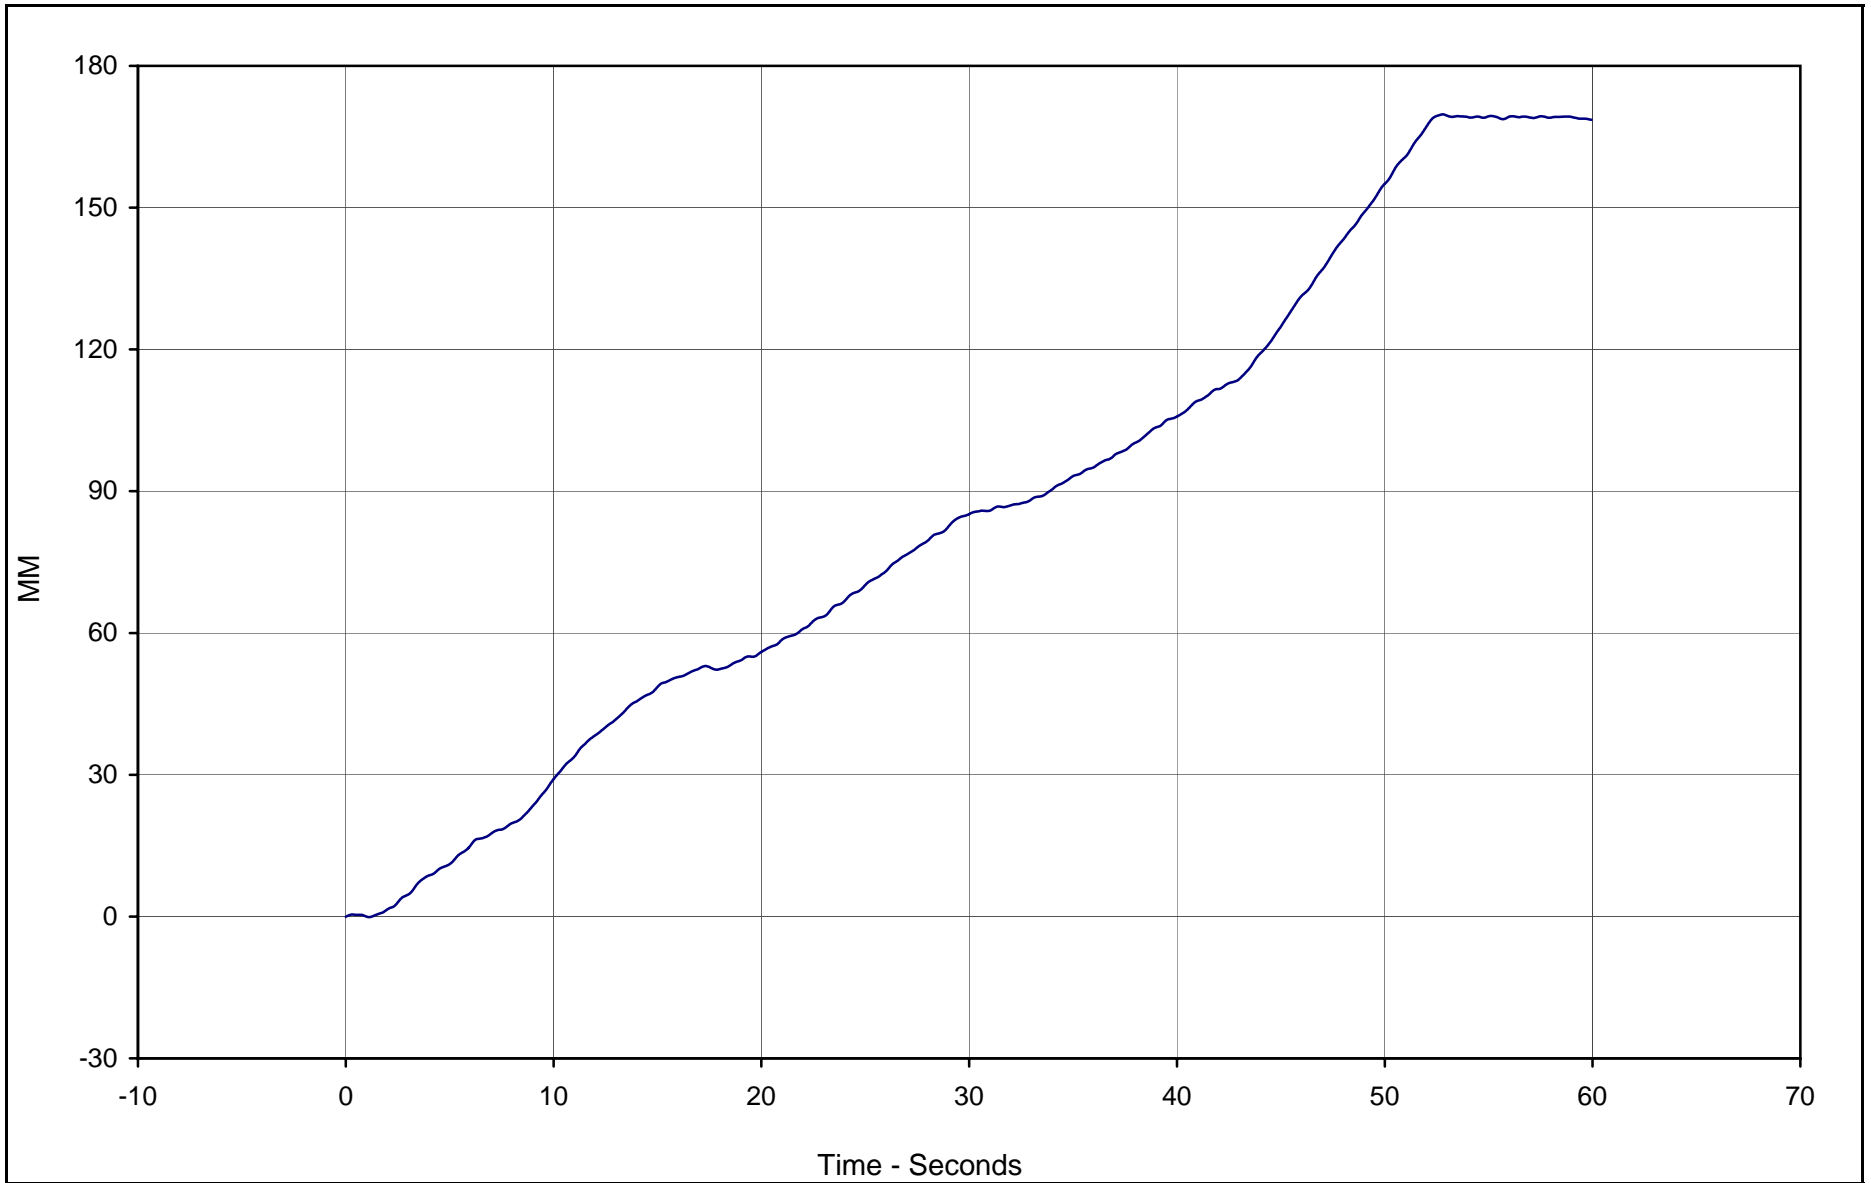
FMVSS 223 REAR IMPACT GUARD (PRE-TEST)

Trailer Guard Description	Test Date	Test Location	Curve Description	Sample Number	Maximum Displ.(mm)	Time at Max. (sec)	Displ. Rate (mm/min)
2007 TransFreight Technology	9/7/07	P1 Left Side	Displ. vs. Time	01	169.7	N/A	N/A

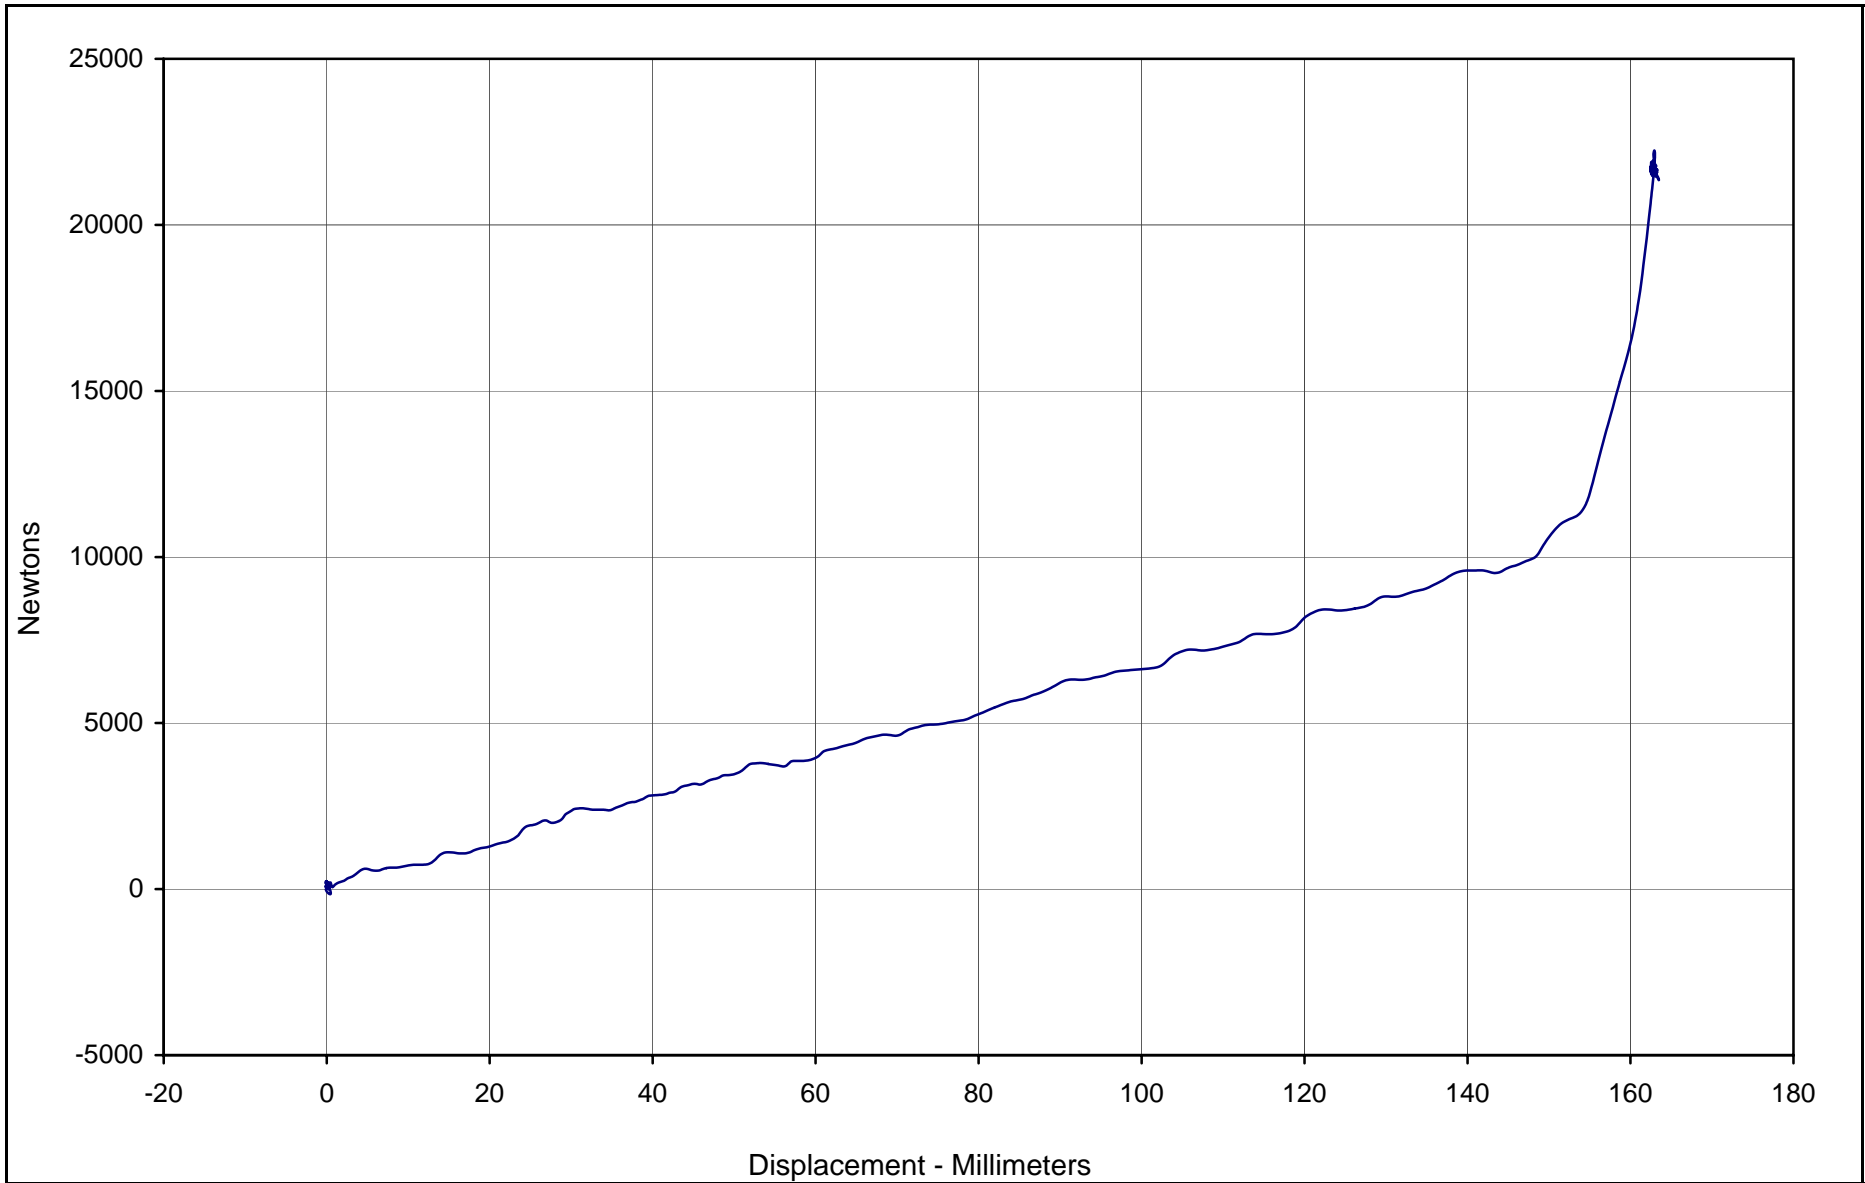
FMVSS 223 REAR IMPACT GUARD (PRE-TEST)

Trailer Guard Description	Test Date	Location	Curve Description	Sample Number	Maximum Load (N)	Displacements (mm)	
						At 47.5kN	At Max.
2007 TransFreight Technology	9/5/07	P2 Center	Force vs. Displ.	01	22,240	N/A	162.9

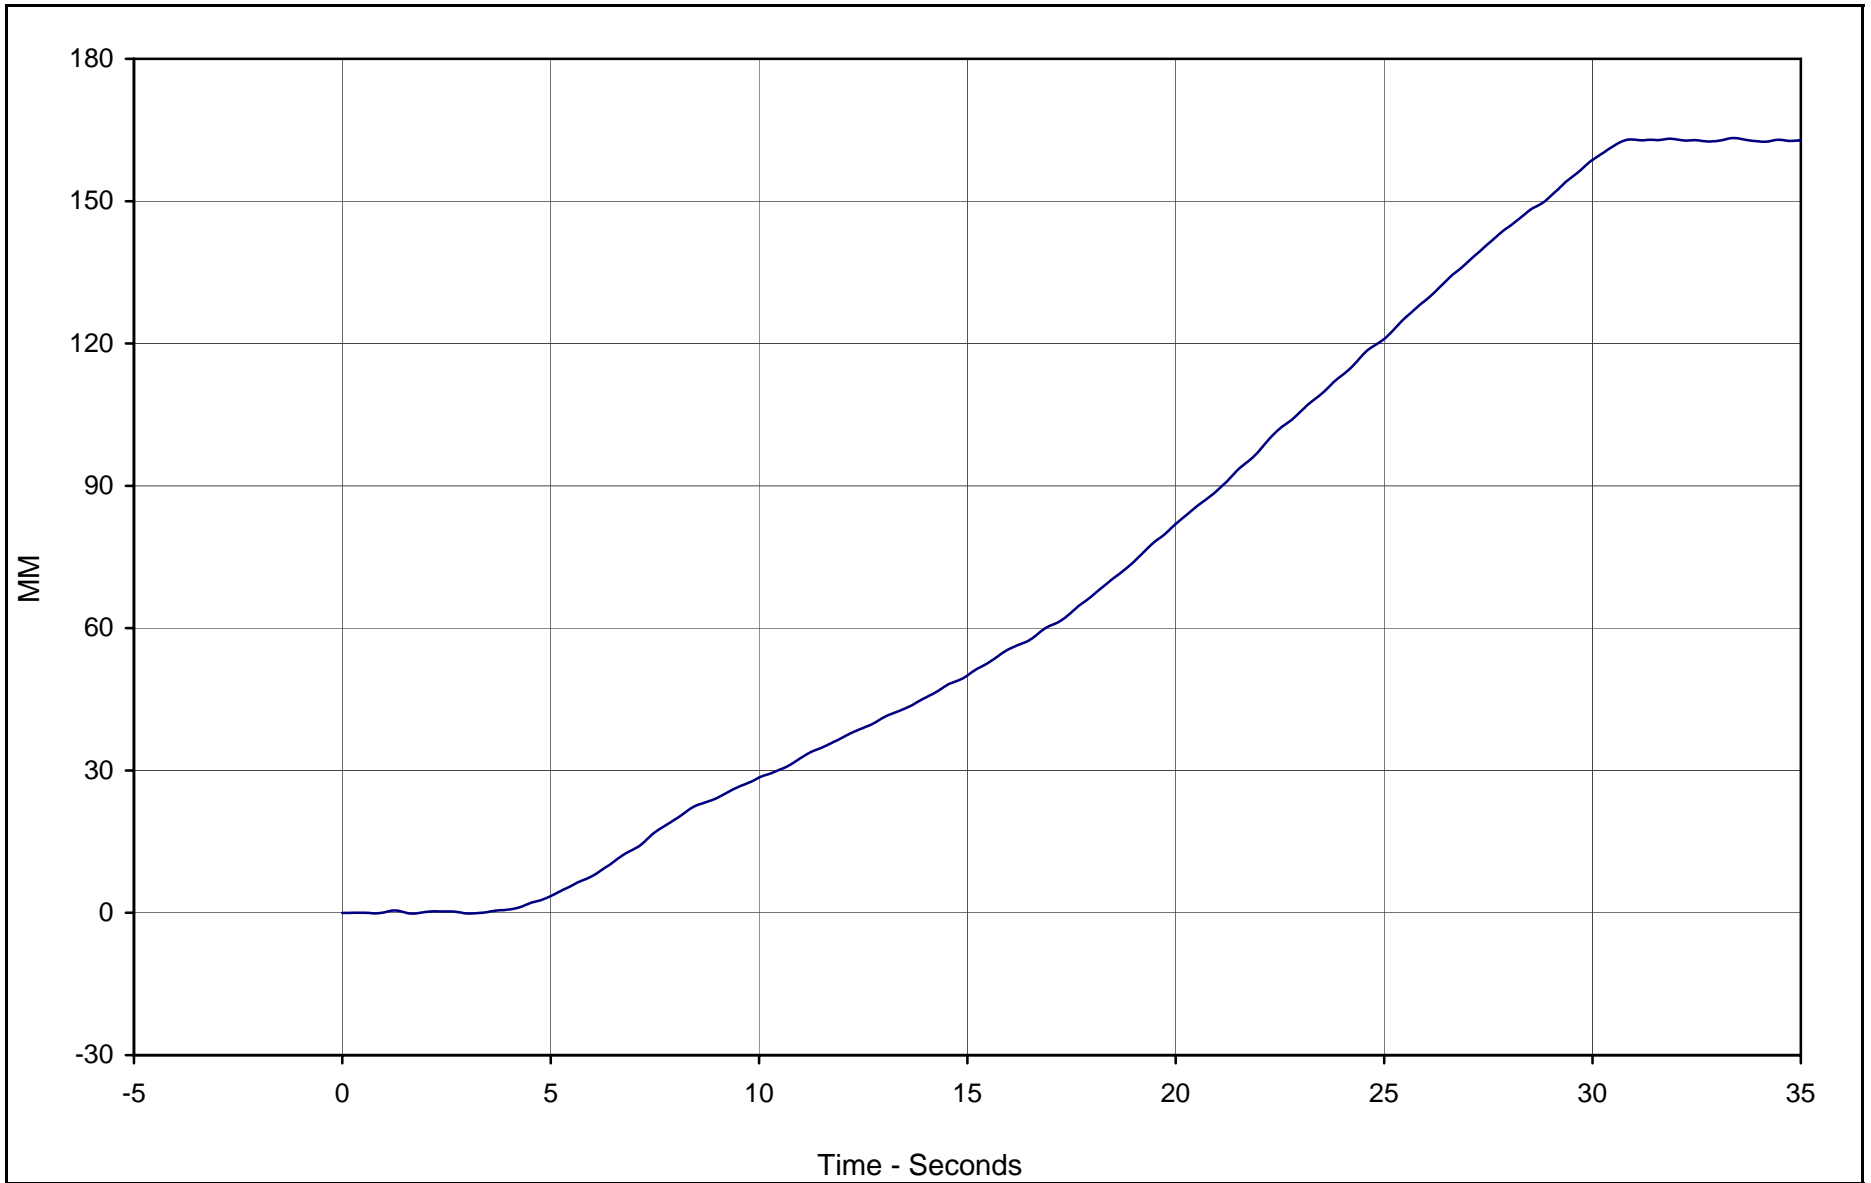
FMVSS 223 REAR IMPACT GUARD (PRE-TEST)

Trailer Guard Description	Test Date	Test Location	Curve Description	Sample Number	Maximum Displ.(mm)	Time at Max. (sec)	Displ. Rate (mm/min)
2007 TransFreight Technology	9/5/07	P2 Center	Displ. vs. Time	01	163.5	N/A	N/A

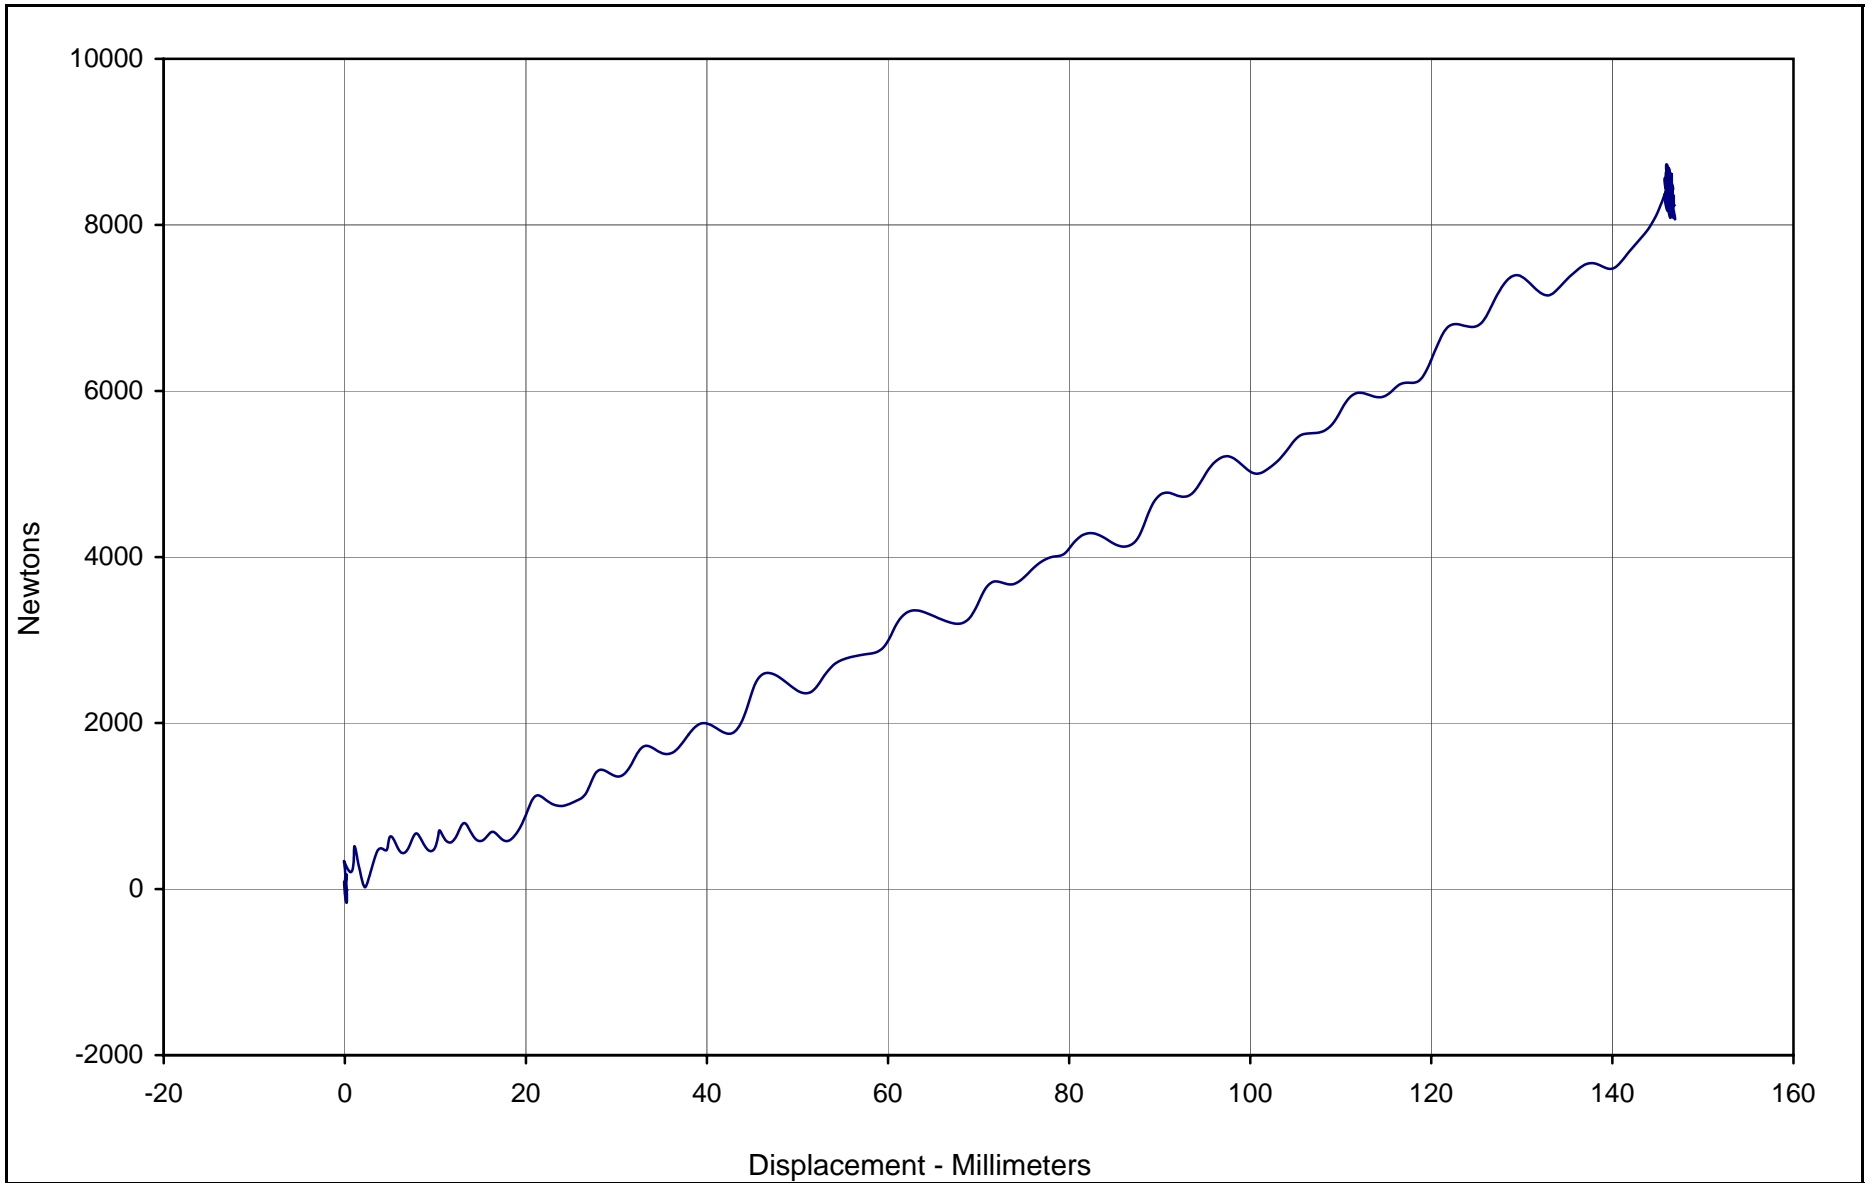
FMVSS 223 REAR IMPACT GUARD (PRE-TEST)

Trailer Guard Description	Test Date	Location	Curve Description	Sample Number	Maximum Load (N)	Displacements (mm)	
						At 47.5kN	At Max.
2007 TransFreight Technology	9/7/07	P3 Left Side	Displ. vs. Time	01	8,729	N/A	146.0

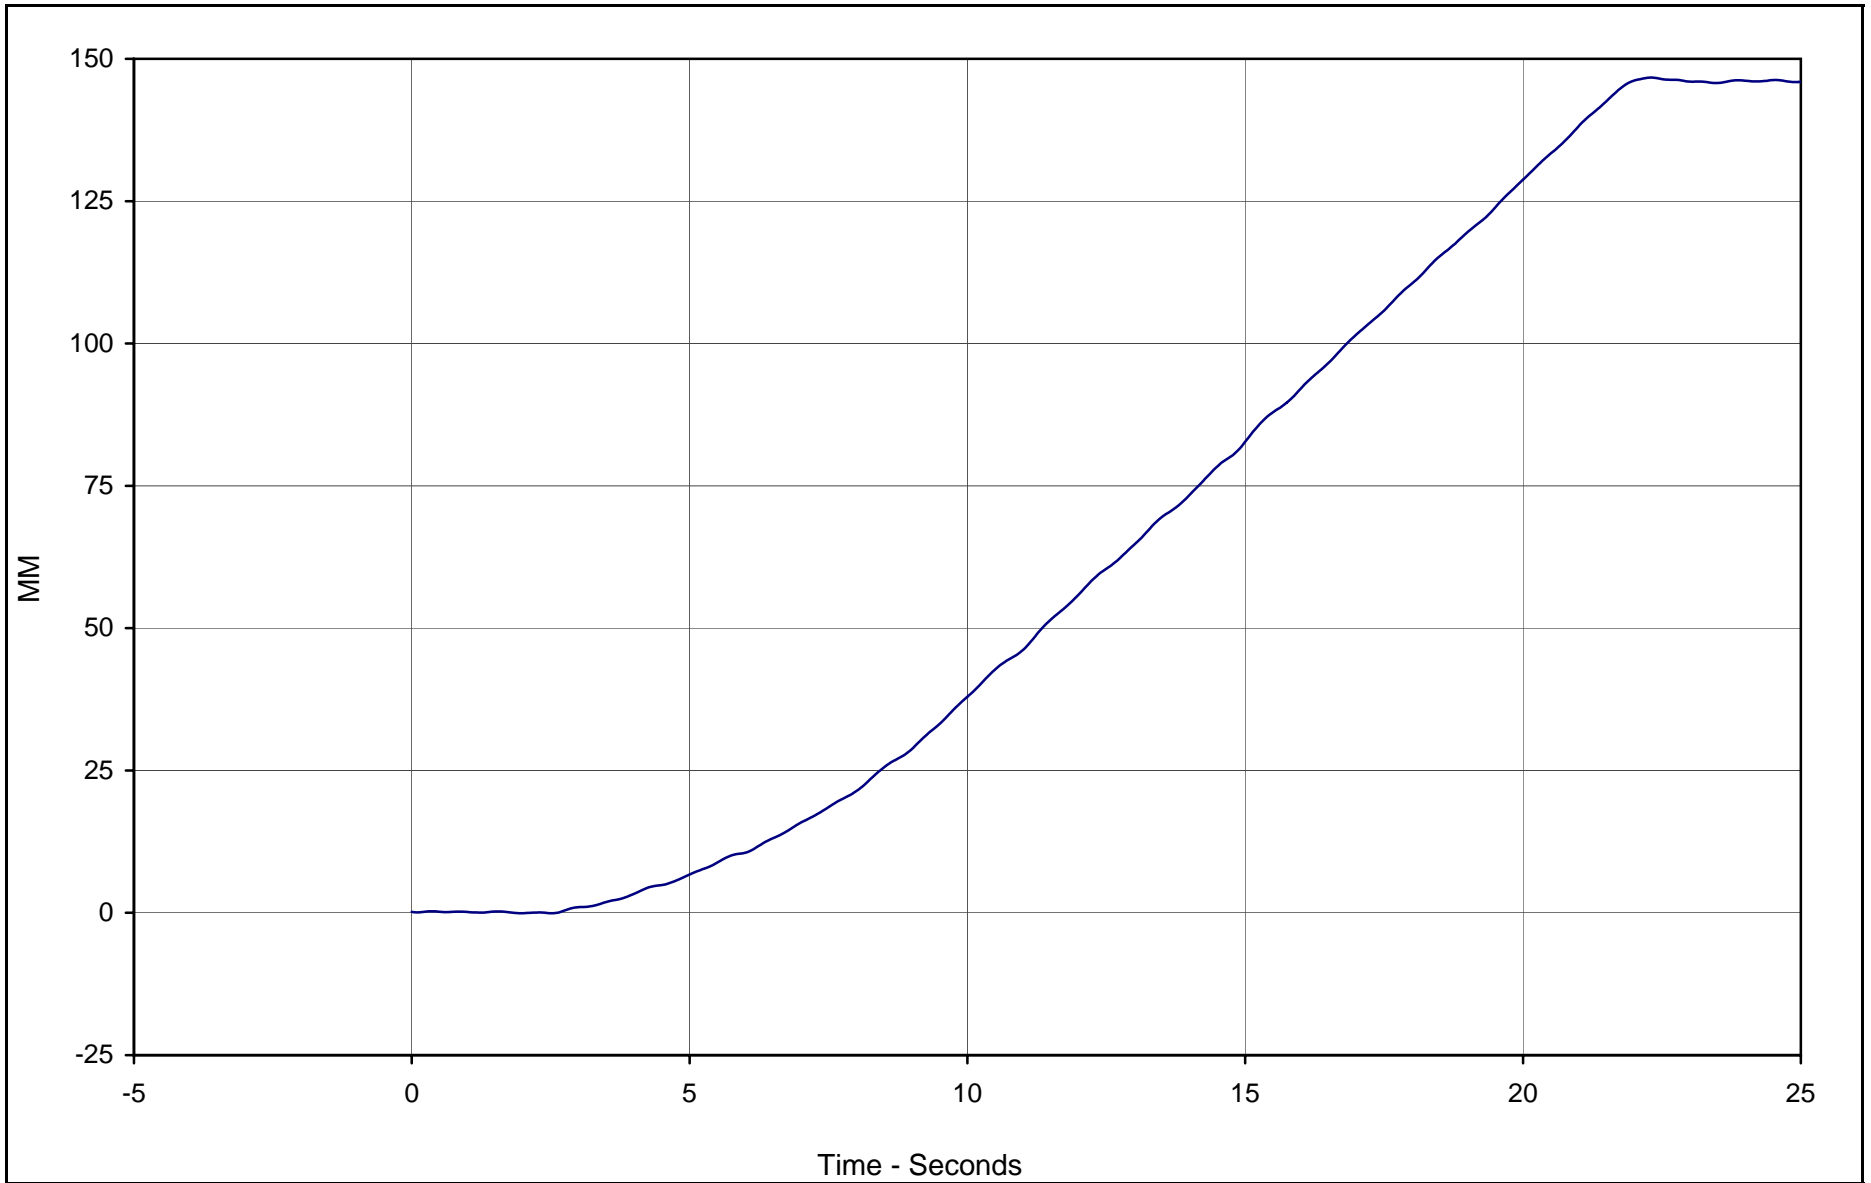
FMVSS 223 REAR IMPACT GUARD (PRE-TEST)

Trailer Guard Description	Test Date	Test Location	Curve Description	Sample Number	Maximum Displ.(mm)	Time at Max. (sec)	Displ. Rate (mm/min)
2007 TransFreight Technology	9/7/07	P3 Left Side	Displ. vs. Time	01	146.9	N/A	N/A

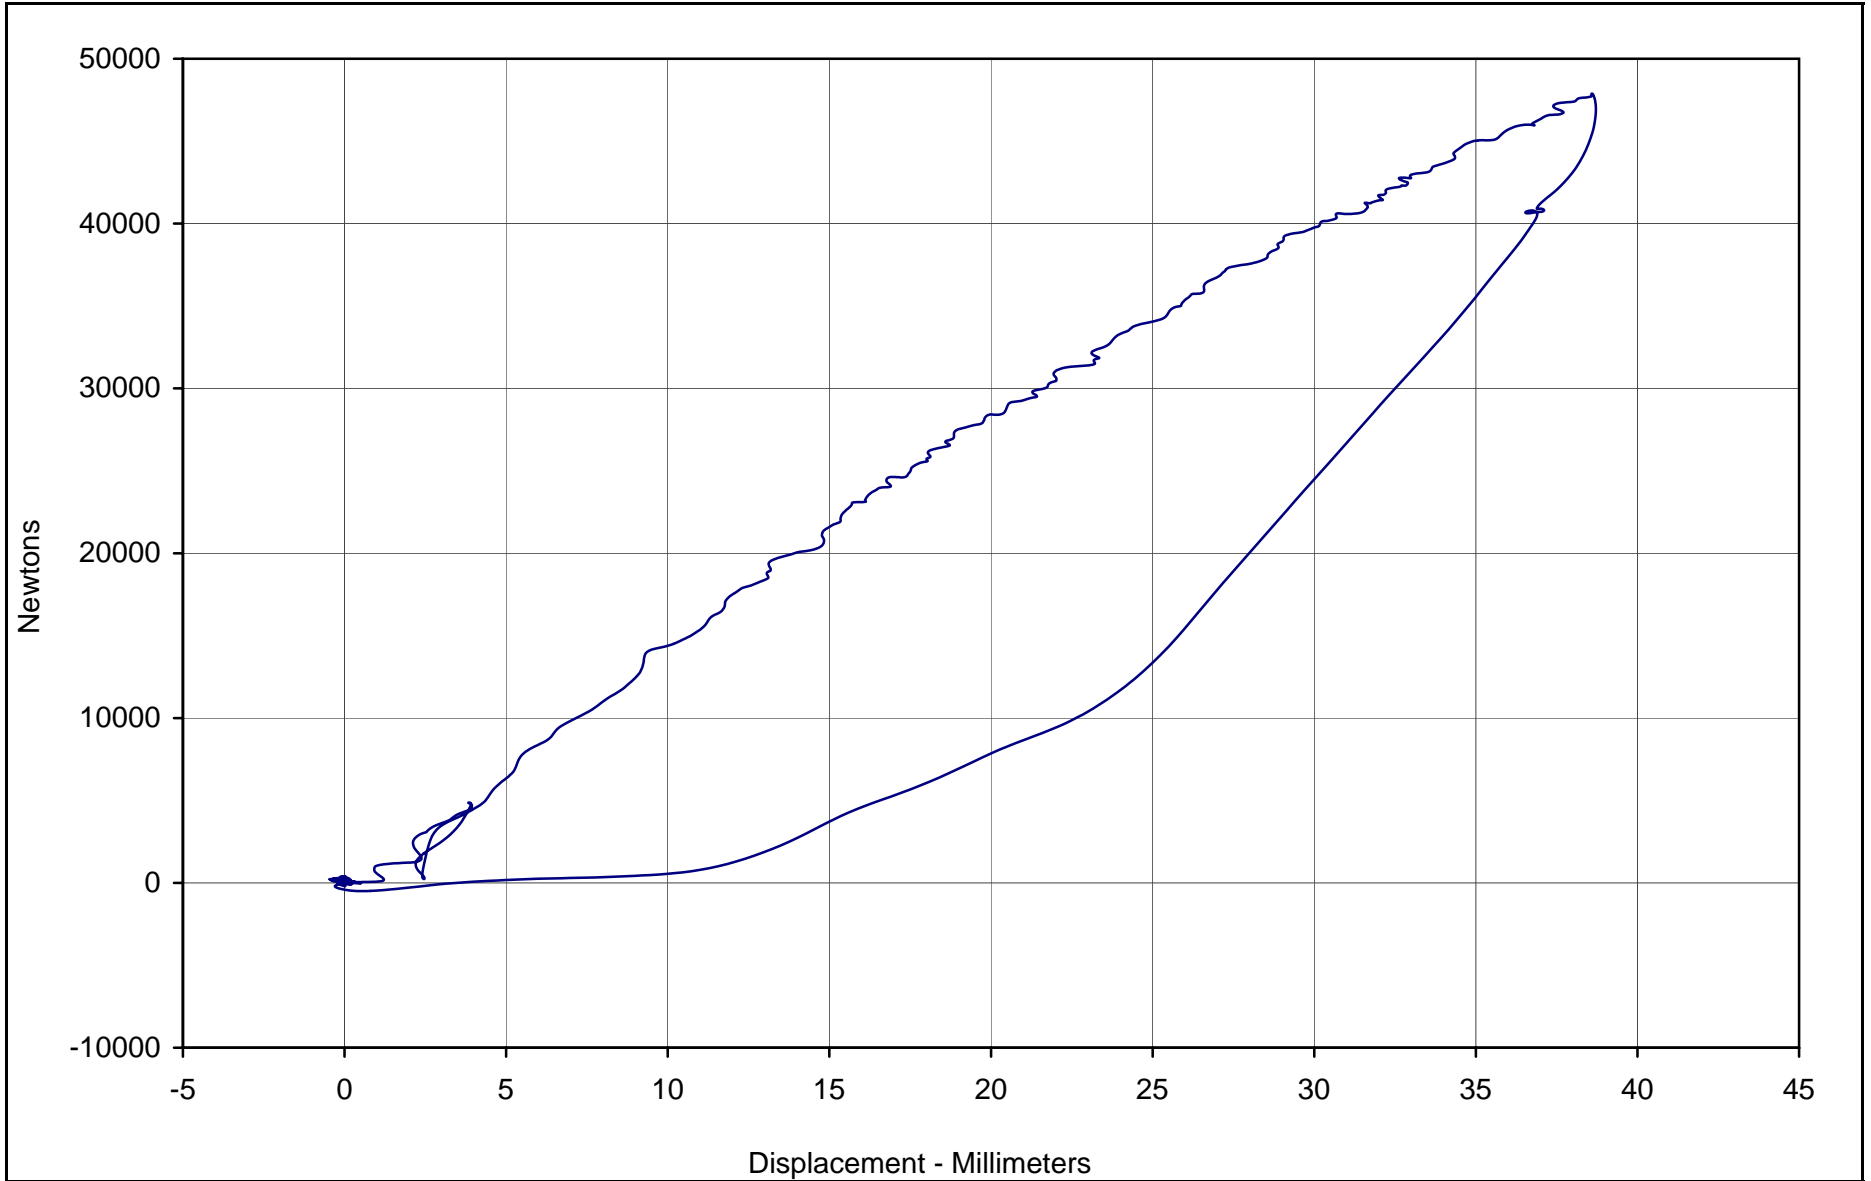
FMVSS 223 REAR IMPACT GUARD

Guard strength tests on sample 1 at location P1 (left side) were conducted on September 7, 2007. The load force was applied until it met the load requirement of 50,000 Newtons (+0, -2500 N). The maximum load achieved was 47,882 N. The average displacement rate was 53.3 mm/min. The rear impact guard displaced 51.6 mm at the minimum required load and 56.0 mm at maximum load. The rear guard assembly sustained 3.2 mm of permanent deformation. The maximum allowable deformation is 130 mm. The data plots of the force versus displacement and displacement versus time are shown on pages 13 and 14.

Trailer Guard Description	Test Date	Test Location	Curve Description	Sample Number	Maximum Load (N)	Displacements (mm)	
						At 47.5kN	At Max.
2007 TransFreight Technology	9/7/07	P1 Left Side	Force vs. Displ.	01	47,882	38.1	38.6

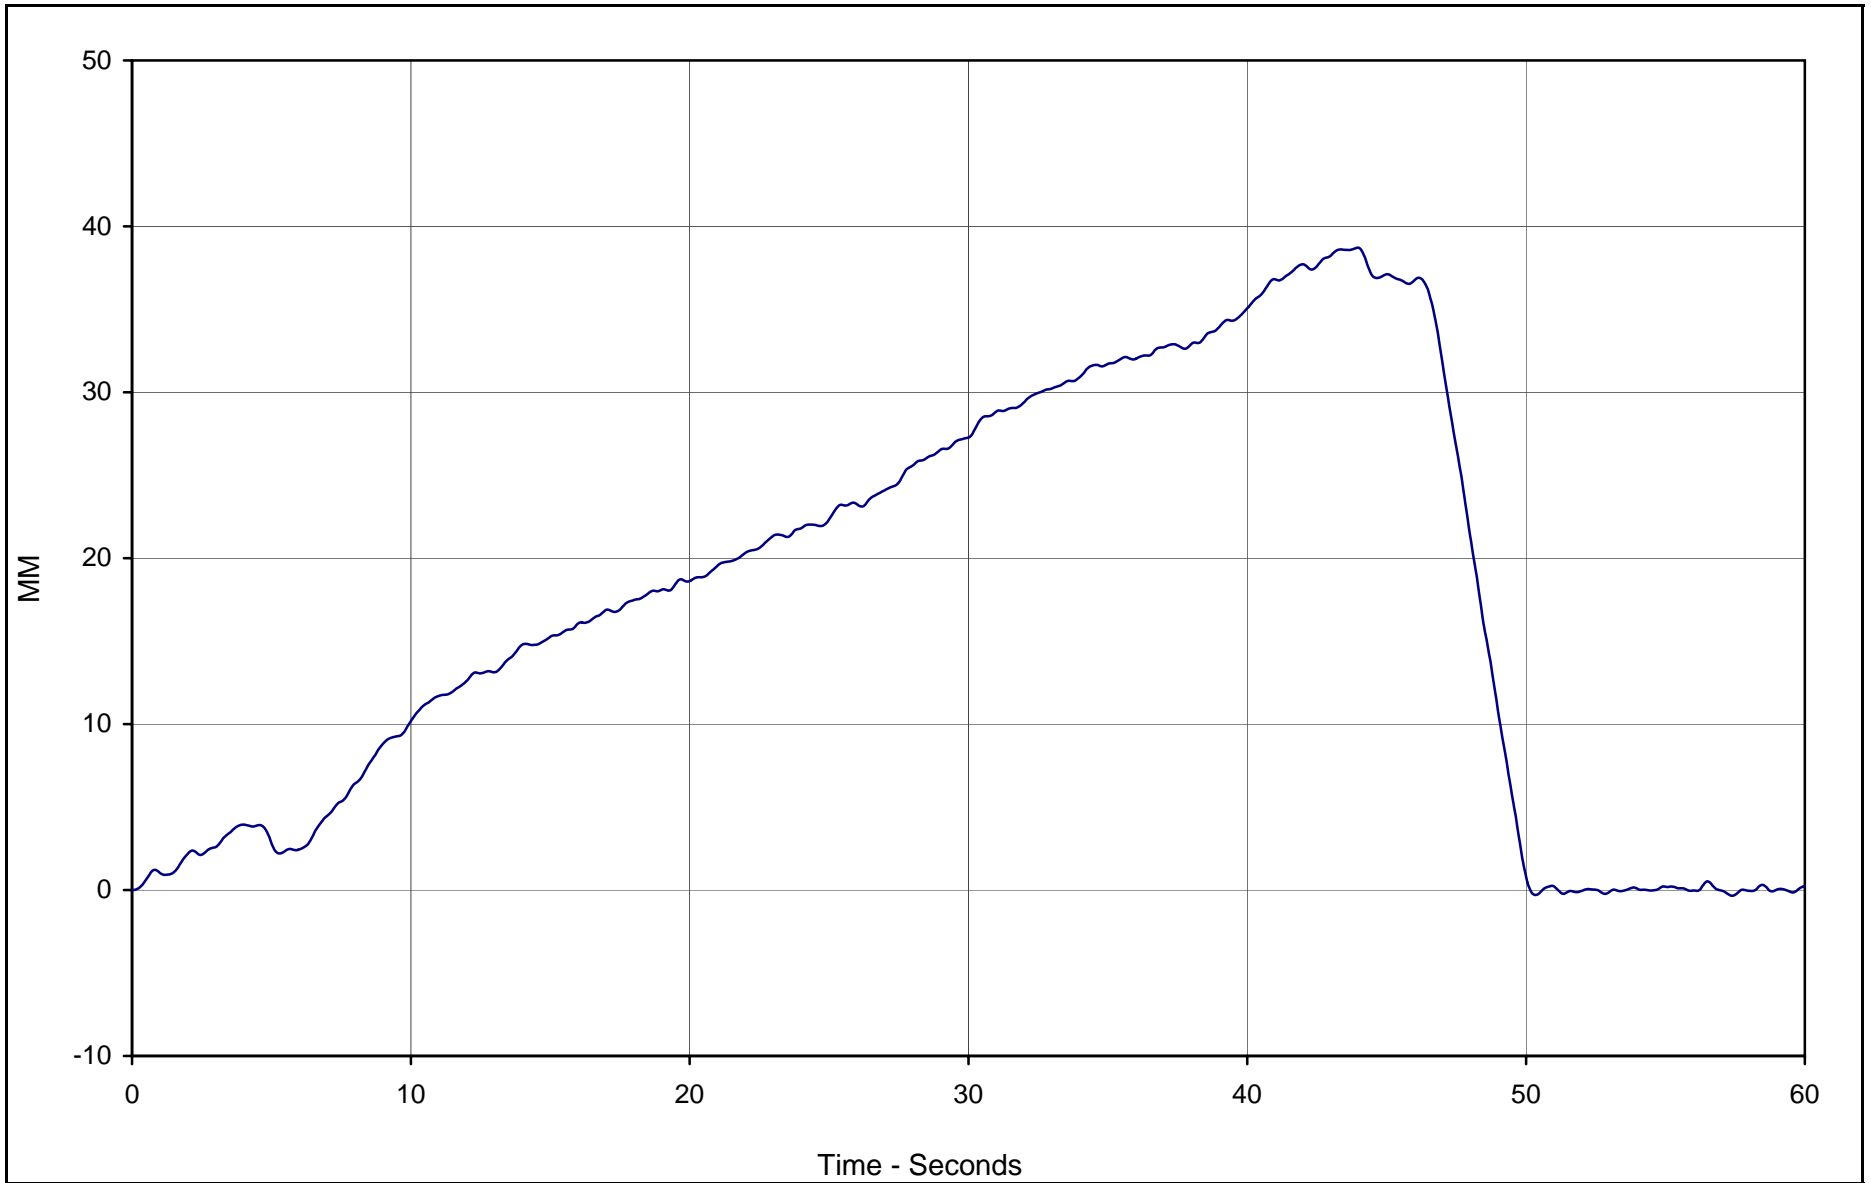
FMVSS 223 REAR IMPACT GUARD

Trailer Guard Description	Test Date	Test Location	Curve Description	Sample Number	Maximum Displ.(mm)	Time at Max. (sec)	Displ. Rate (mm/min)
2007 TransFreight Technology	9/7/07	P1 Left Side	Displ. vs. Time	01	38.7	44.0	53.3

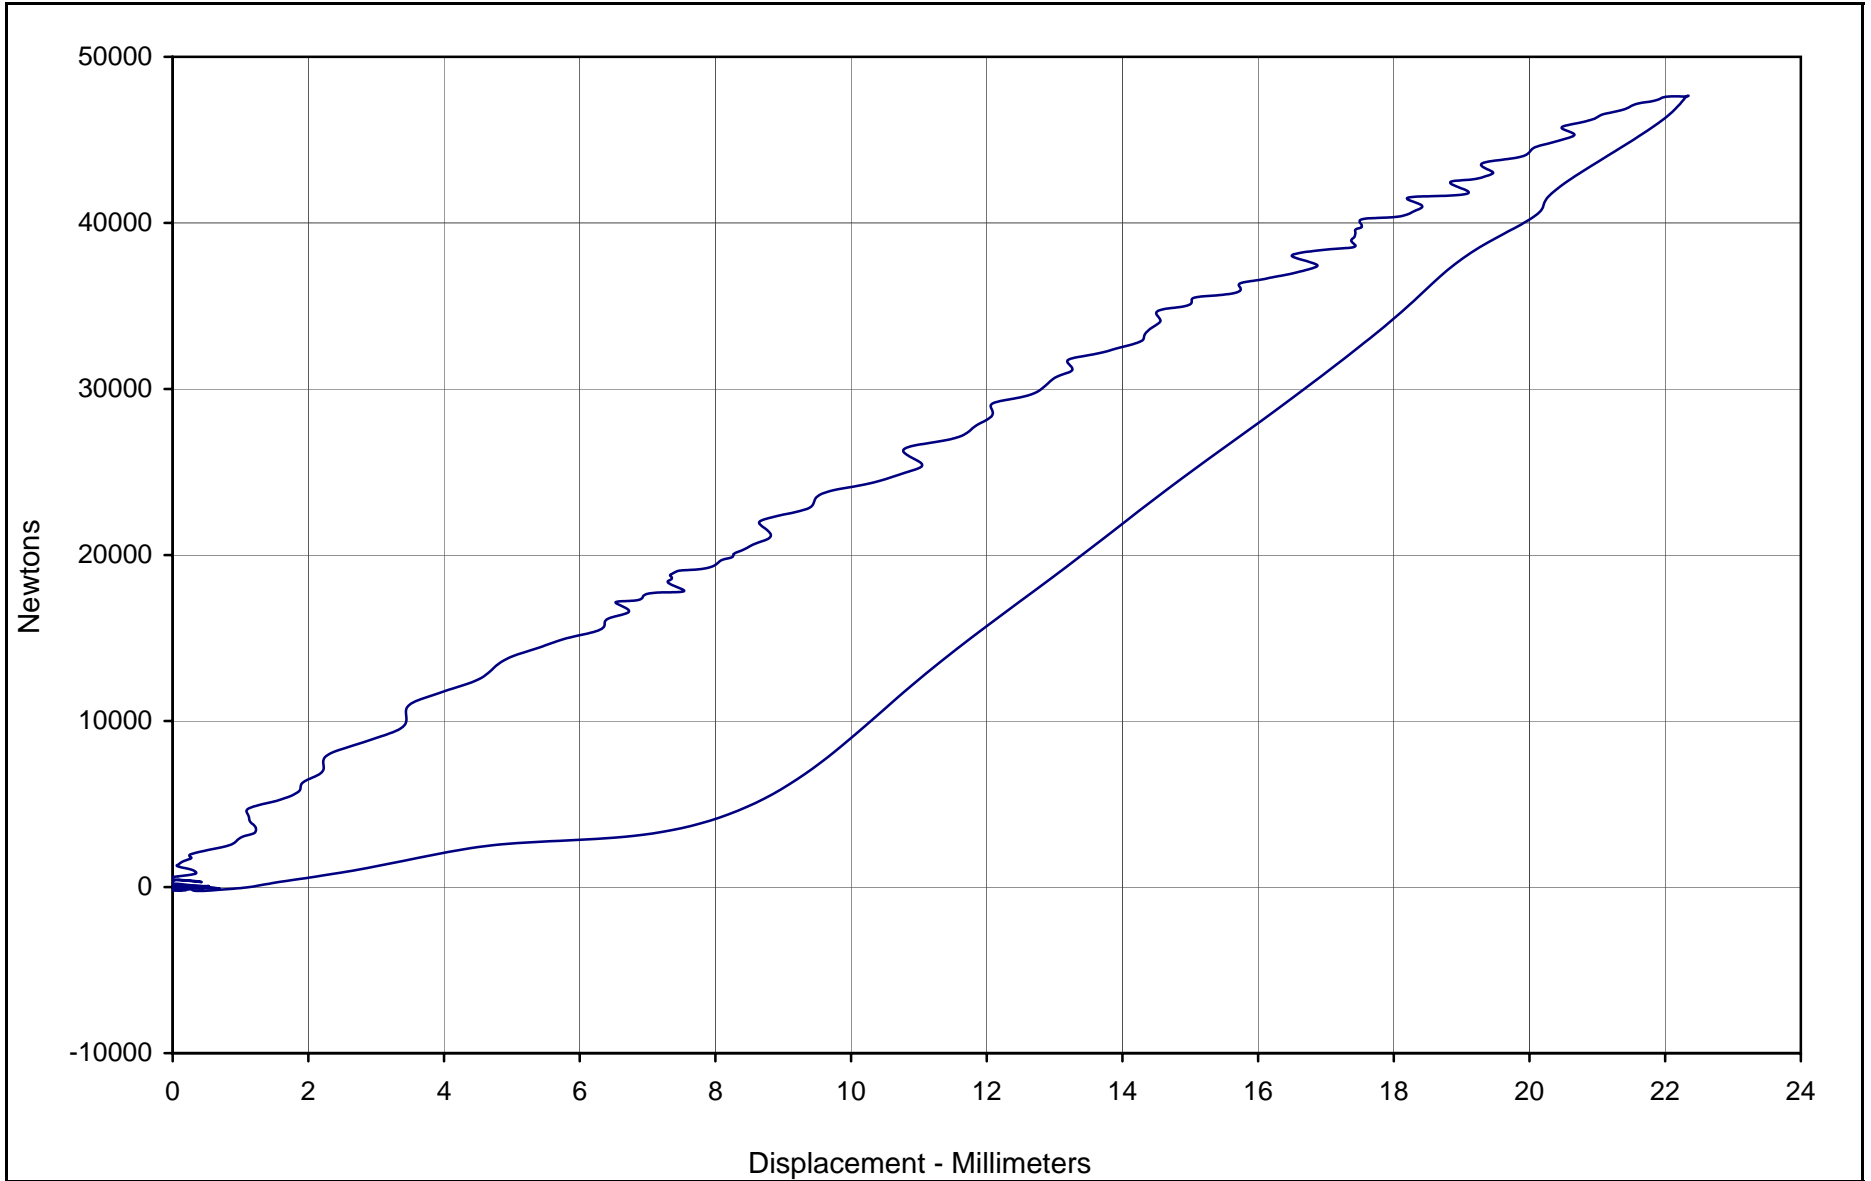
FMVSS 223 REAR IMPACT GUARD

Guard strength tests on sample 1 at location P2 (center) were conducted on September 5, 2007. The load force was applied until it met the load requirement of 50,000 Newtons (+0, -2500 N). The maximum load achieved was 47,658 N. The average displacement rate was 48.0 mm/min. The rear impact guard displaced 22.3 mm at the minimum required load and a maximum of 23.6 mm at maximum load. The rear guard assembly sustained 1.2 mm permanent deformation. The maximum allowable deformation is 130 mm. The data plots of the force versus displacement and displacement versus time are shown on pages 15 and 16.

Trailer Guard Description	Test Date	Location	Curve Description	Sample Number	Maximum Load (N)	Displacements (mm)	
						At 47.5kN	At Max.
2007 TransFreight Technology	9/5/07	P2 Center	Force vs. Displ.	01	47,658	22.0	22.3
