REPORT NO. TR-P27004-09-NC

SAFETY COMPLIANCE TESTING FOR FMVSS 223
REAR IMPACT GUARDS

2007 TRANSFREIGHT TECHNOLOGY

NHTSA NO. RIG 009

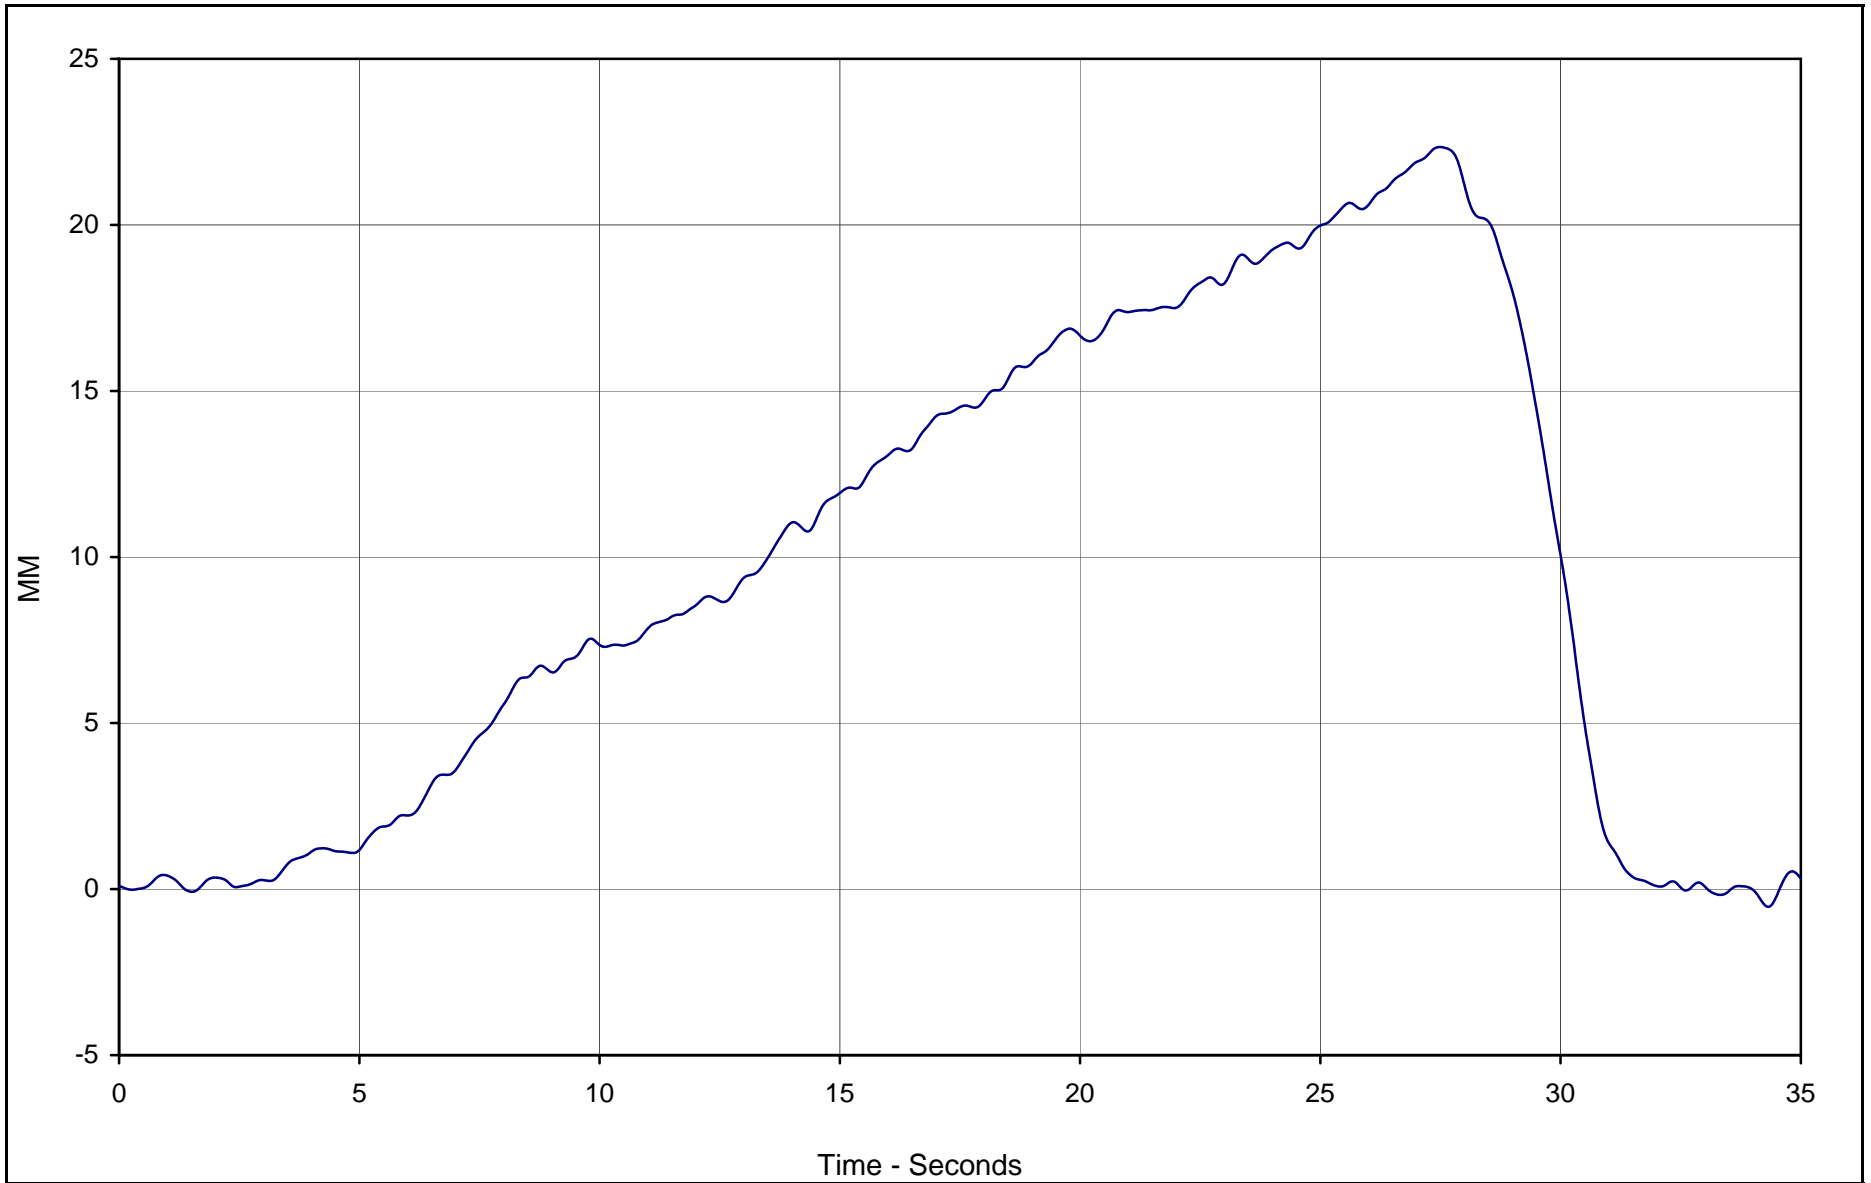
FMVSS 223 REAR IMPACT GUARD

Guard strength tests on sample 1 at location P2 (center) were conducted on September 5, 2007. The load force was applied until it met the load requirement of 50,000 Newtons (+0, -2500 N). The maximum load achieved was 47,658 N. The average displacement rate was 48.0 mm/min. The rear impact guard displaced 22.3 mm at the minimum required load and a maximum of 23.6 mm at maximum load. The rear guard assembly sustained 1.2 mm permanent deformation. The maximum allowable deformation is 130 mm. The data plots of the force versus displacement and displacement versus time are shown on pages 15 and 16.

Trailer Guard Description	Test Date	Test Location	Curve Description	Sample Number	Maximum Displ.(mm)	Time at Max. (sec)	Displ. Rate (mm/min)
2007 TransFreight Technology	9/5/07	P2 Center	Displ. vs. Time	01	22.3	27.5	48.0

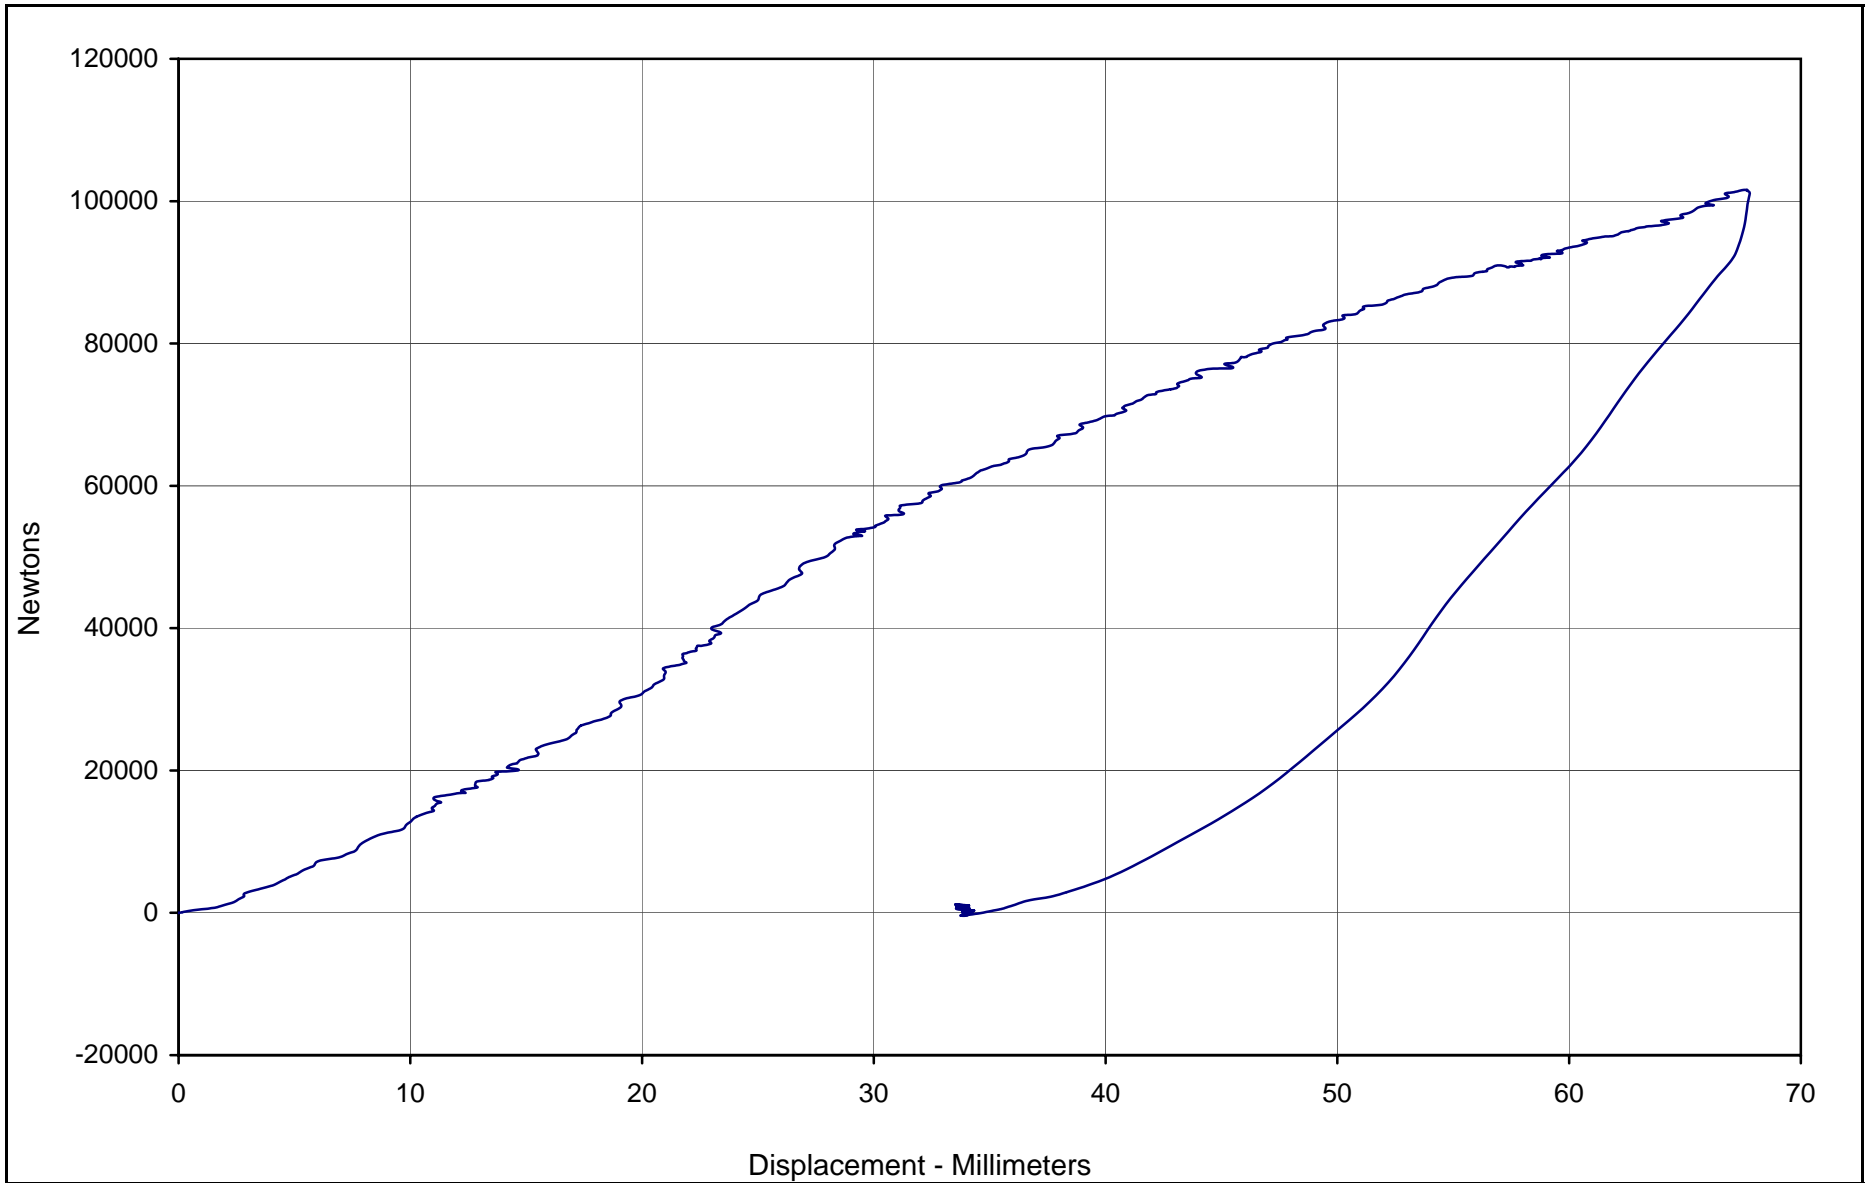
FMVSS 223 REAR IMPACT GUARD

The guard strength test at P3 was performed on September 7, 2007. The force was applied until the rear impact guard displaced 67.6 mm. The maximum load achieved was 101,591 N. The rear impact guard sustained permanent deformation of 34.5 mm. The maximum allowable deformation of 130 mm was not exceeded. The force requirement for this test was met.

Trailer Guard Description	Test Date	Location	Curve Description	Sample Number	Measured Energy (J)	Maximum Load (N)	Displacements (mm)	
							At 100kN	At Max.
2007 TransFreight Technology	9/7/07	P3 Left Side	Force vs. Displ.	01	N/A*	101,591	66.1	67.6

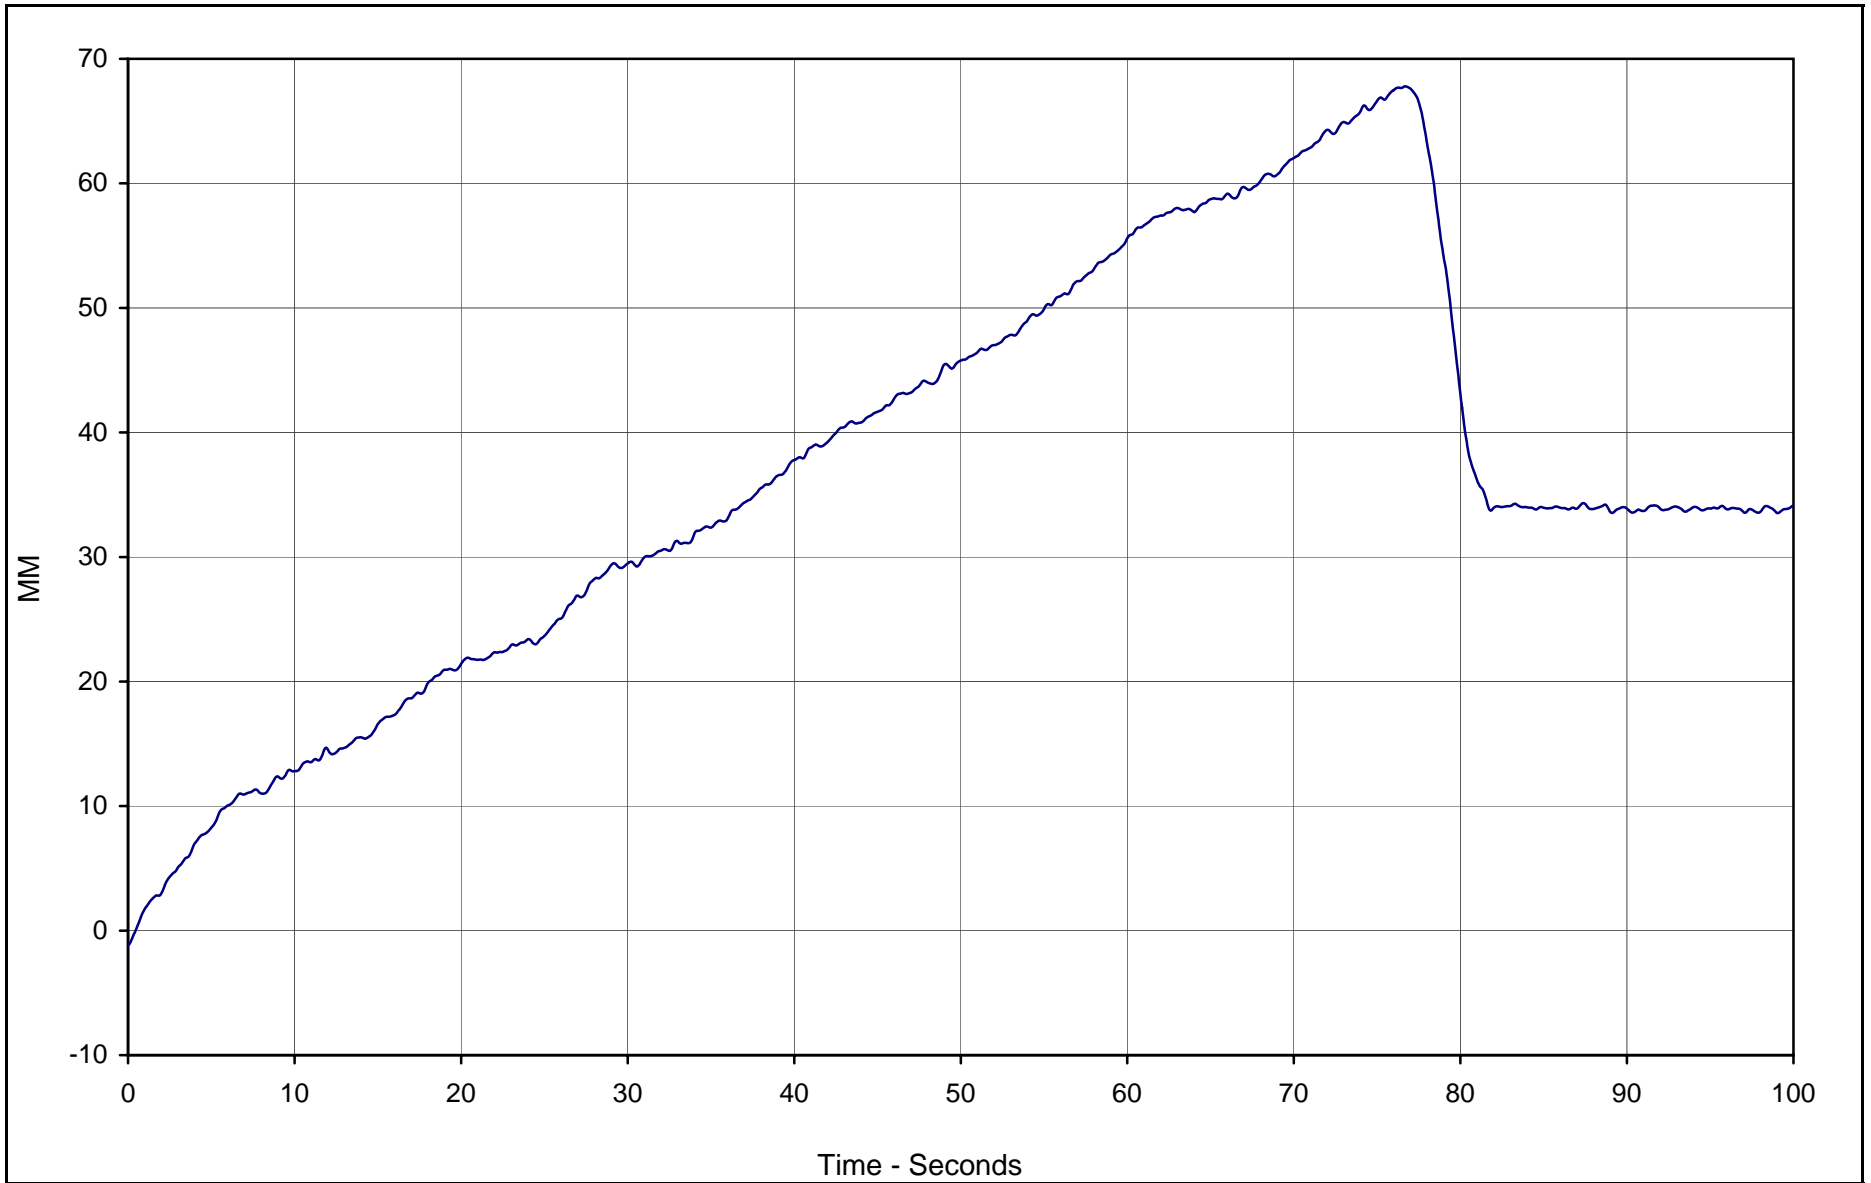
FMVSS 223 REAR IMPACT GUARD

Trailer Guard Description	Test Date	Test Location	Curve Description	Sample Number	Maximum Displ.(mm)	Time at Max. (sec)	Displ. Rate (mm/min)
2007 TransFreight Technology	9/7/07	P3 Left Side	Displ. vs. Time	01	67.8	76.7	53.1

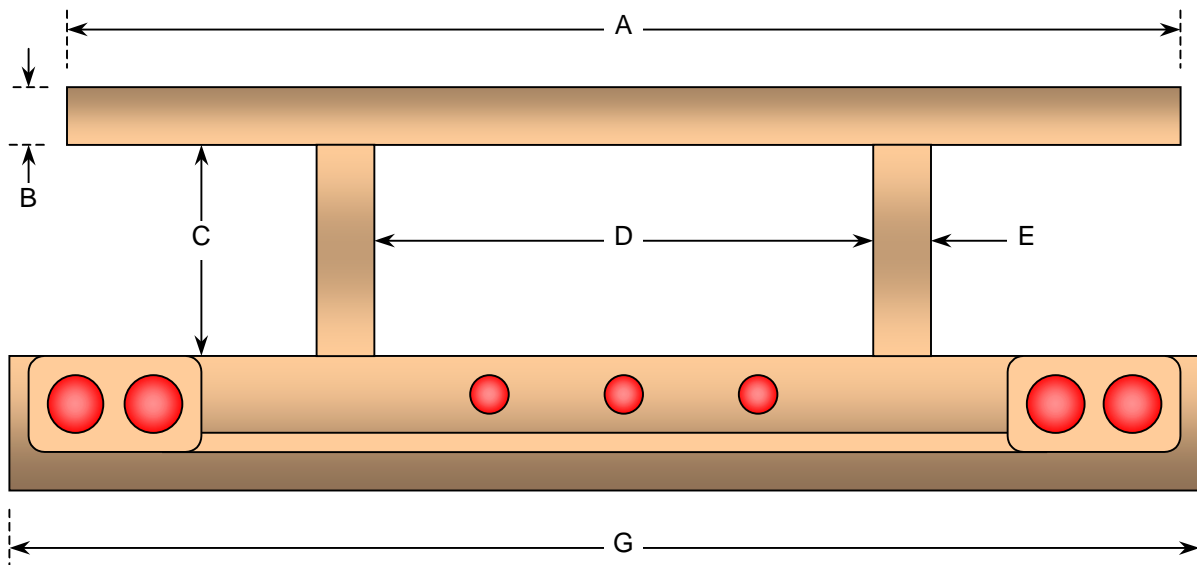
Guard Assembly Rear View

Item	Measurement Description	Value (mm)
A	Horizontal Member Maximum Width	2390
B	Horizontal Member Vertical Cross-Section	100
C	Vertical Support Member Height	580
D	Vertical Support Member Inside Separation	1030
E	Vertical Support Member Maximum Width	102
F	Rear Floor Thickness	n/a
G	Rear Floor Cross-Member Width	n/a

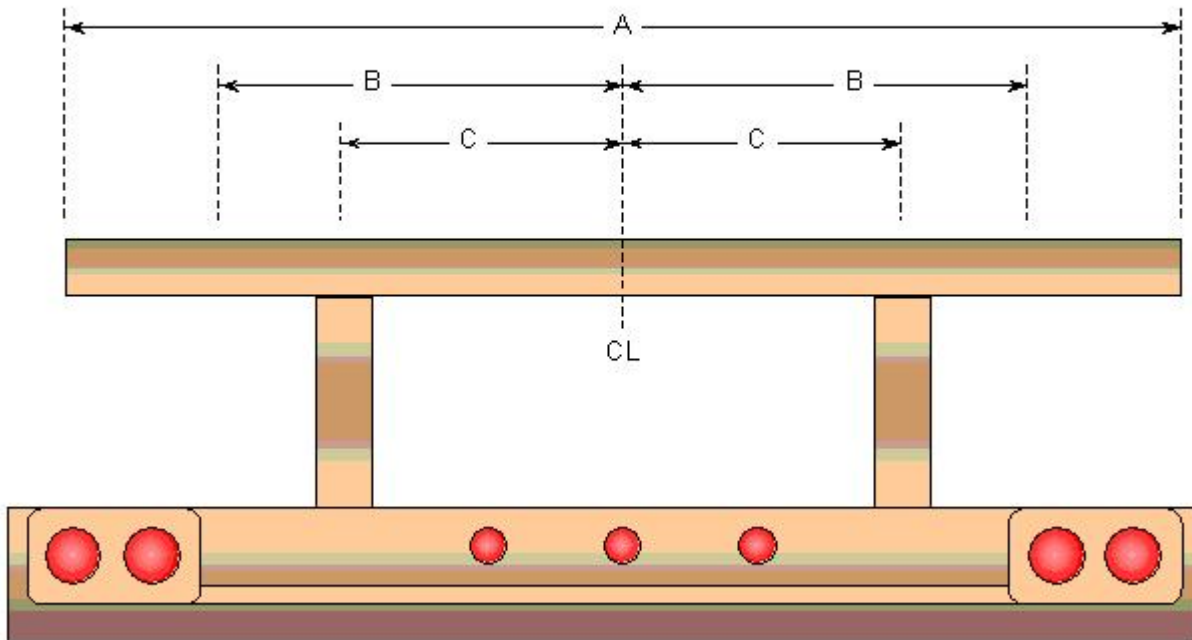
Guard Assembly Rear View

Item	Measurement Description	Value (mm)
A	Horizontal Member Width (reference)	2390
B	3/8 Horizontal Member Width, P1 Location	896
C	P3 Location (between 355 mm and 635 mm from the centerline)	635
CL	P2 Location at Centerline	1195

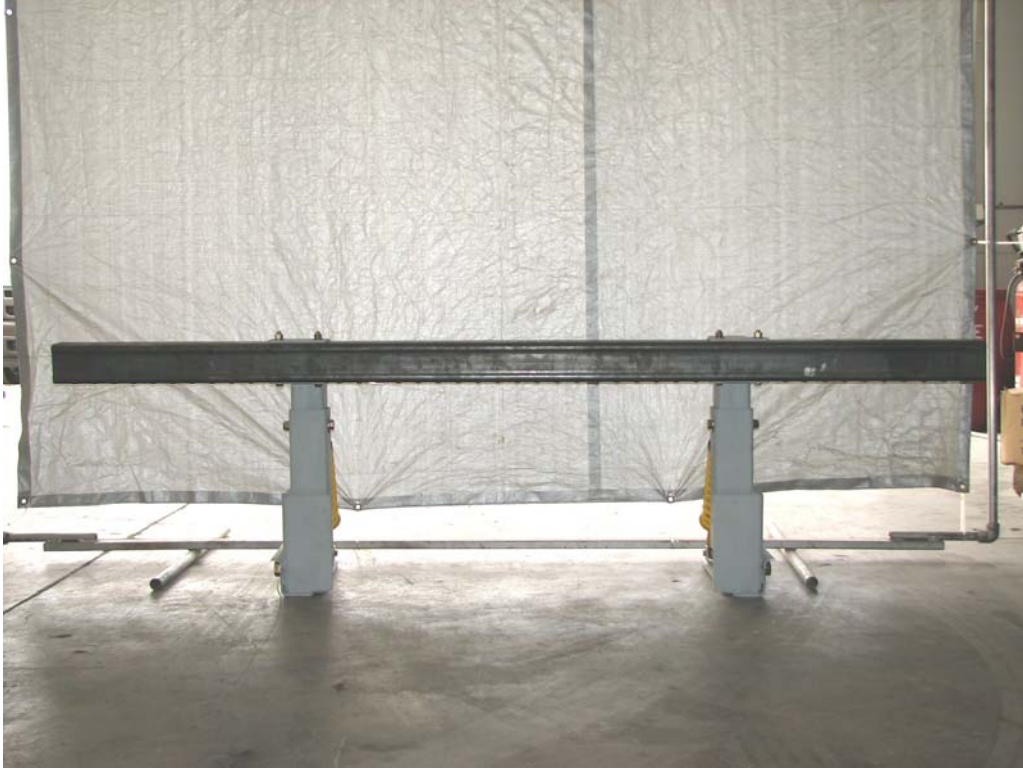
Figure 1. Front View, as Received

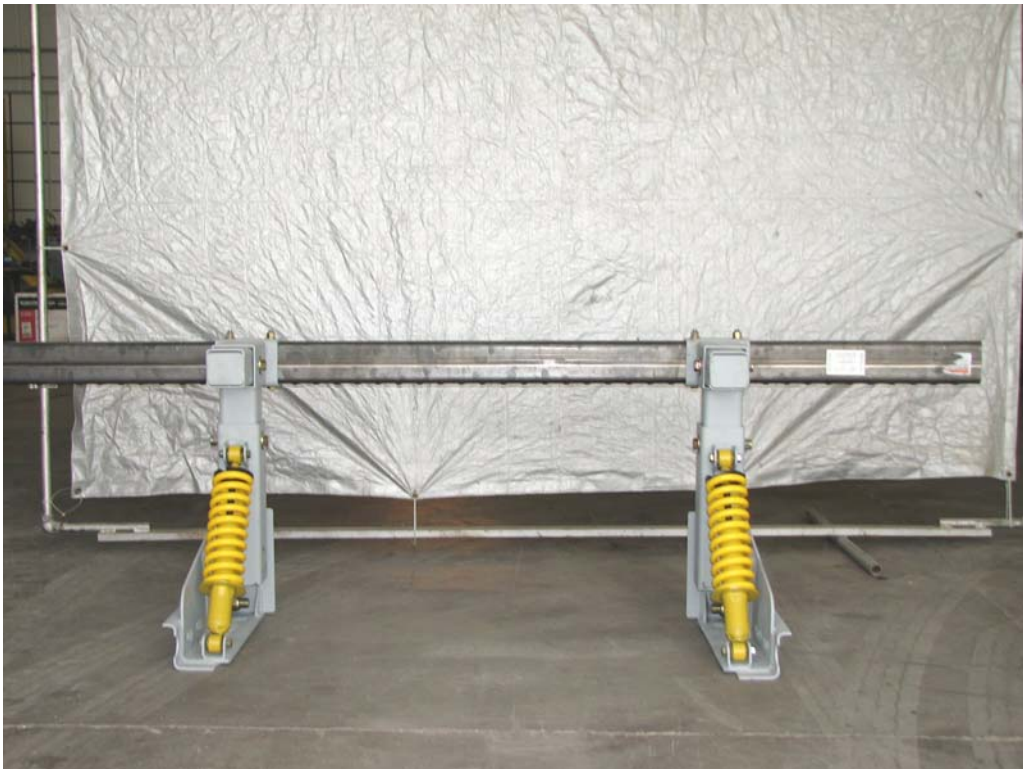
Figure 2. Rear View, as Received

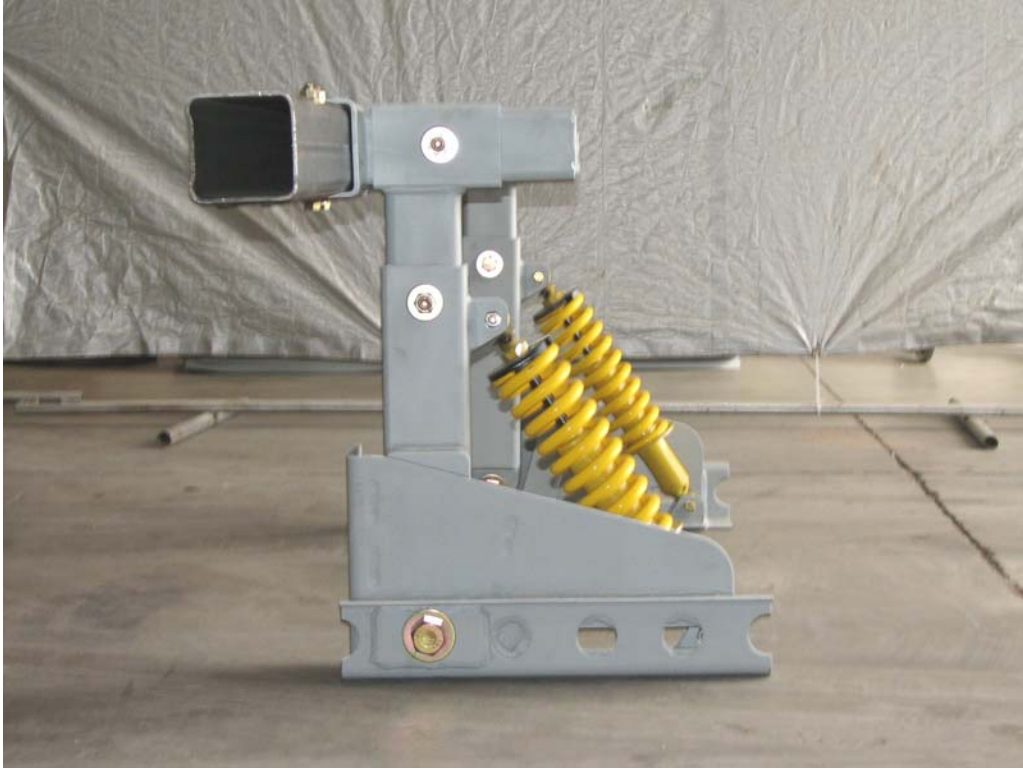
Figure 3. Right Side, as Received

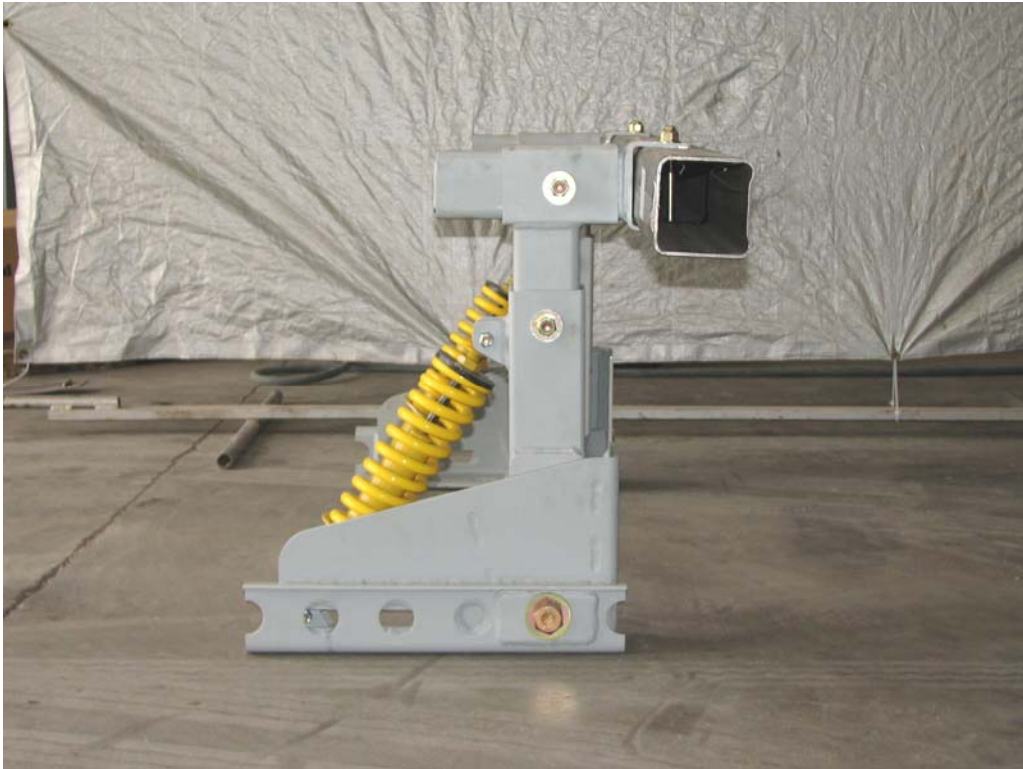
Figure 4. Left Side, as Received

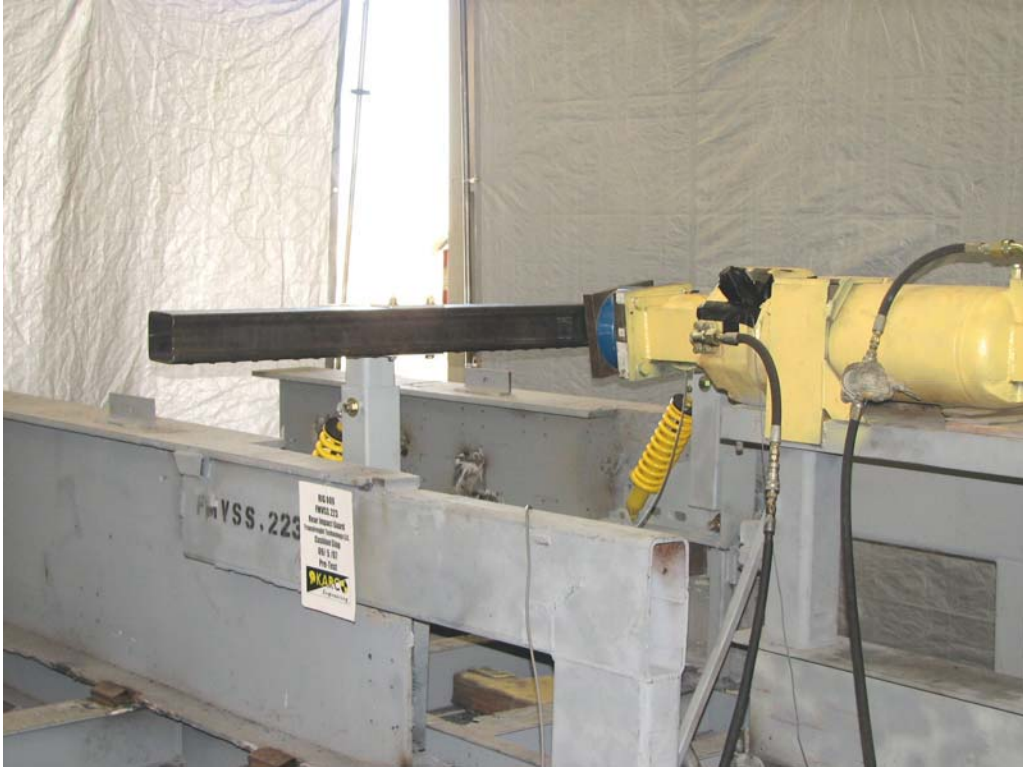
The test specimen was positioned and rigidly secured to Karco's test fixture. The test frame consists of two wide flange 2444 mm by 690 mm beams to provide rigid mounting surfaces for the rear impact guard assembly. A six-inch bore hydraulic actuator was mounted on a rigid reaction frame and welded in place on the test fixture. The cylinder rod was connected to a force application device consisting of a solid stainless steel sheet measuring 203 mm in height, 203 mm in width, and 25 mm in thickness with a 5 mm radius of curvature on each edge of the contact surface. The force application device was used to apply the required loads to the rear impact guard assembly.

Figure 5. Test Setup

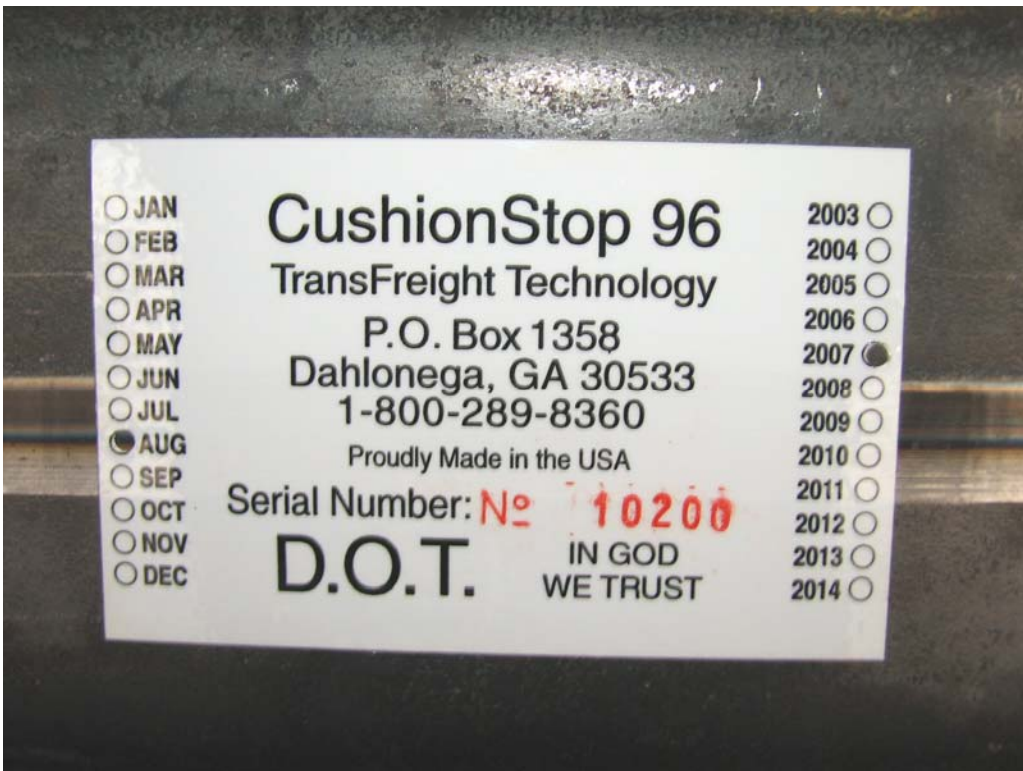
The rear impact guard met the labeling requirements of FMVSS No. 223, Section S5.3, as detailed on page 5, Data Sheet No. 1.

Figure 6. Manufacturer's Label

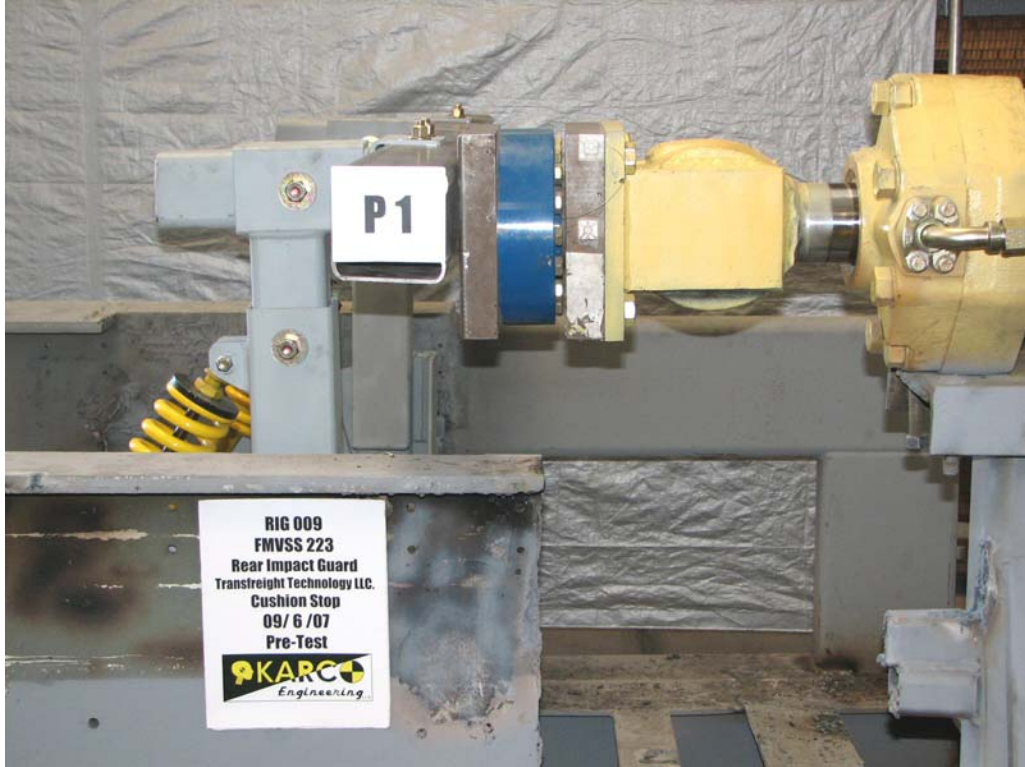
Figure 7. Pre-Test, Location P1, Unloaded

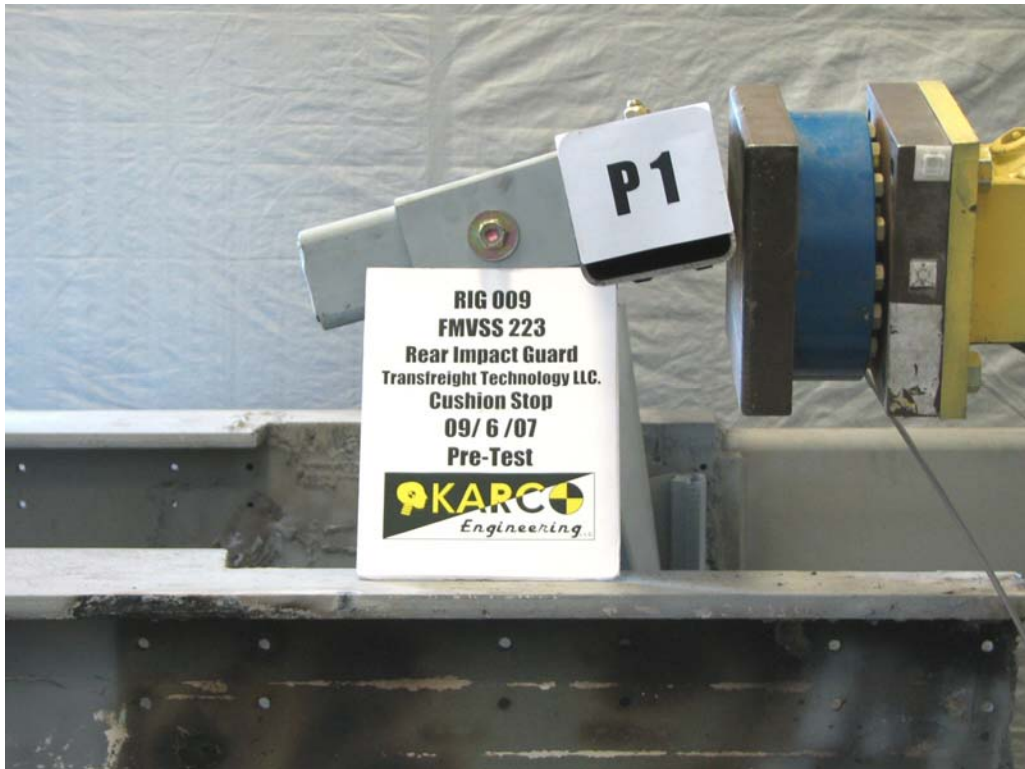
Figure 8. Pre-Test, Location P1, Loaded

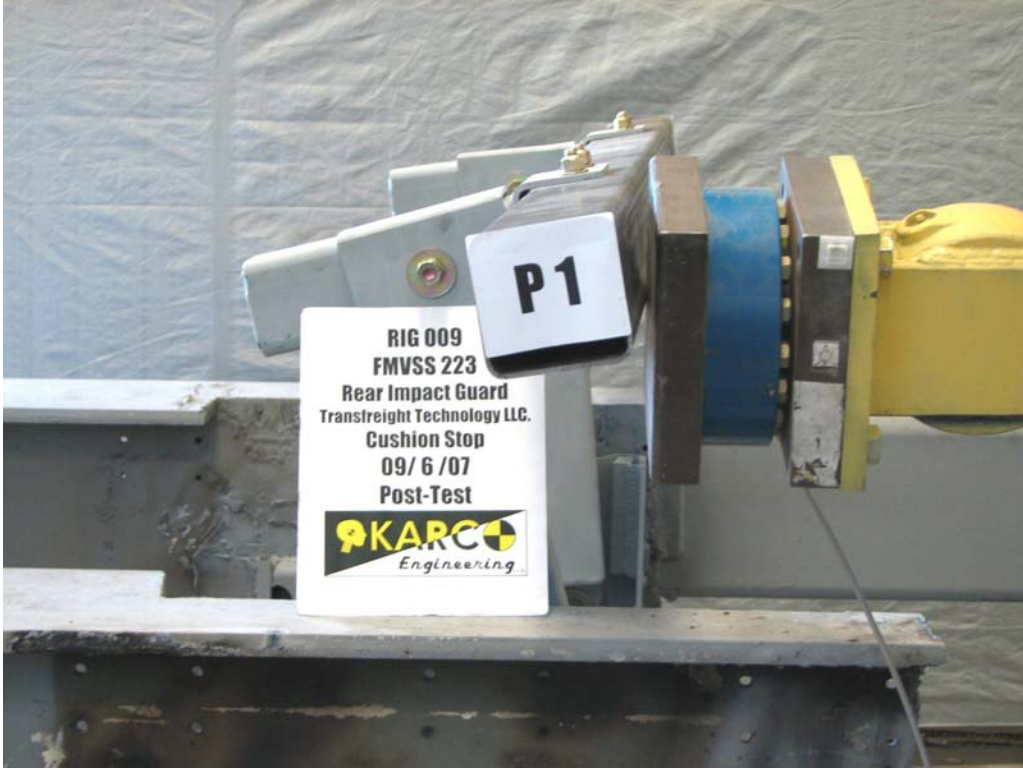
Guard strength tests on sample 1 at location P1 (left side) were conducted on September 7, 2007. The load force was applied until it met the load requirement of 50,000 Newtons (+0, -2500 N). The maximum load achieved was 47,882 N. The average displacement rate was 53.3 mm/min. The rear impact guard displaced 51.6 mm at the minimum required load and 56.0 mm at maximum load. The rear guard assembly sustained 3.2 mm of permanent deformation. The maximum allowable deformation is 130 mm. The data plots of the force versus displacement and displacement versus time are shown on pages 13 and 14.

Figure 9. Post-Test, Location P1, Loaded

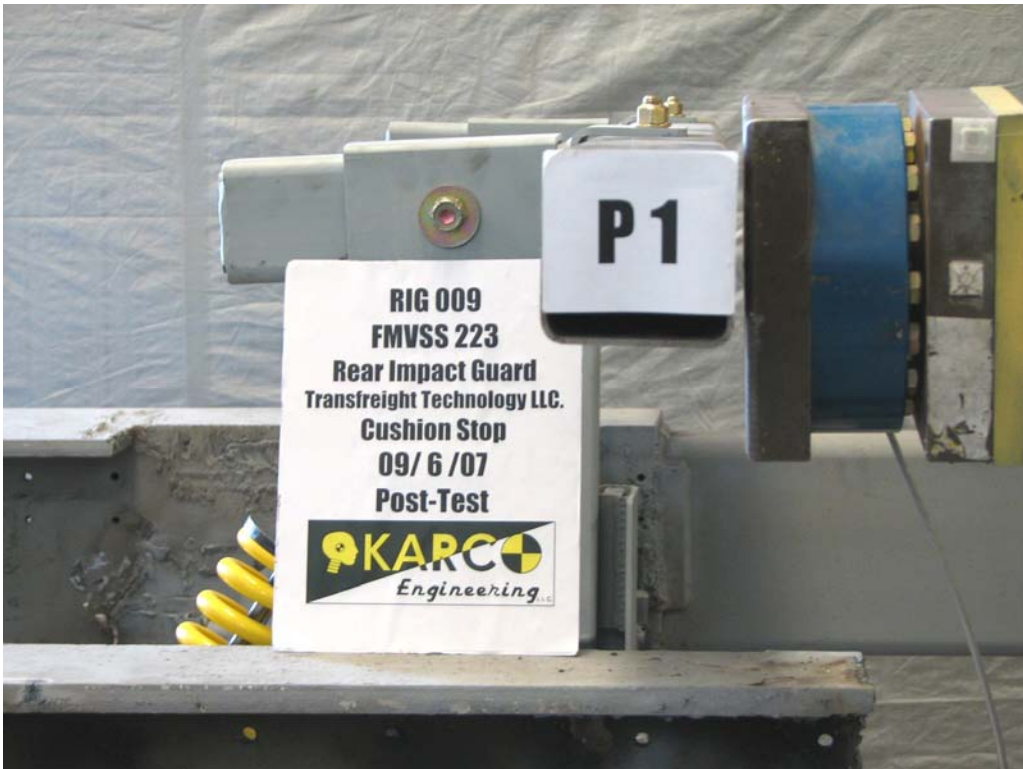
Figure 10. Post-Test, Location P1, Unloaded

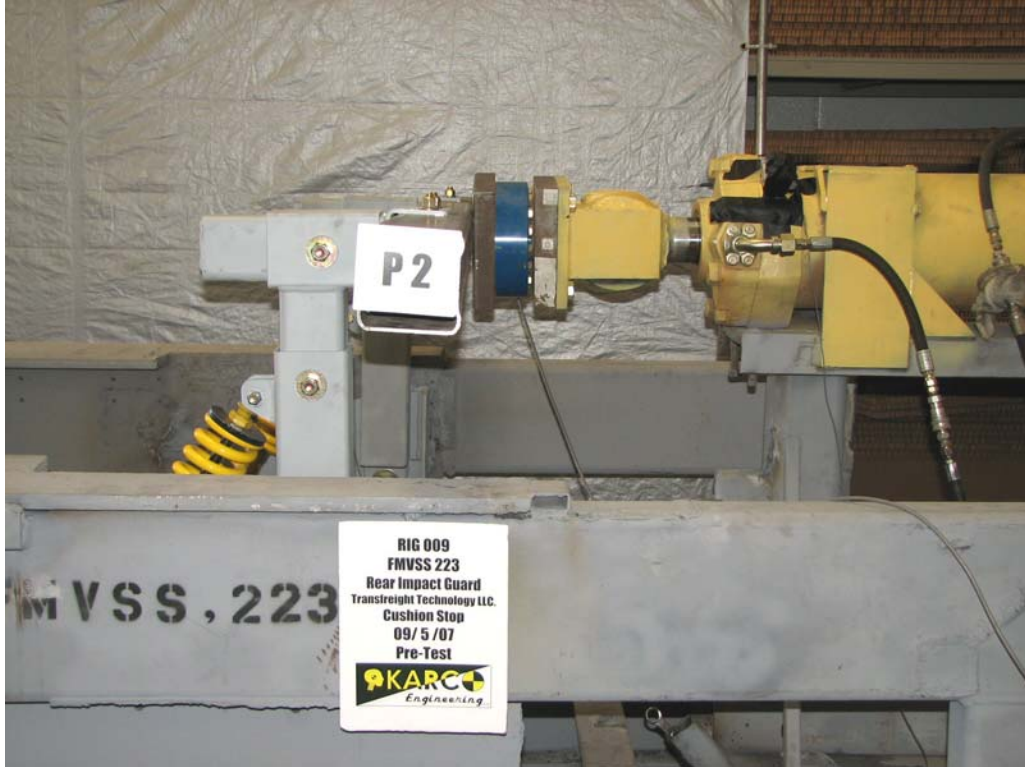
Figure 11. Pre-Test, Location P2, Unloaded

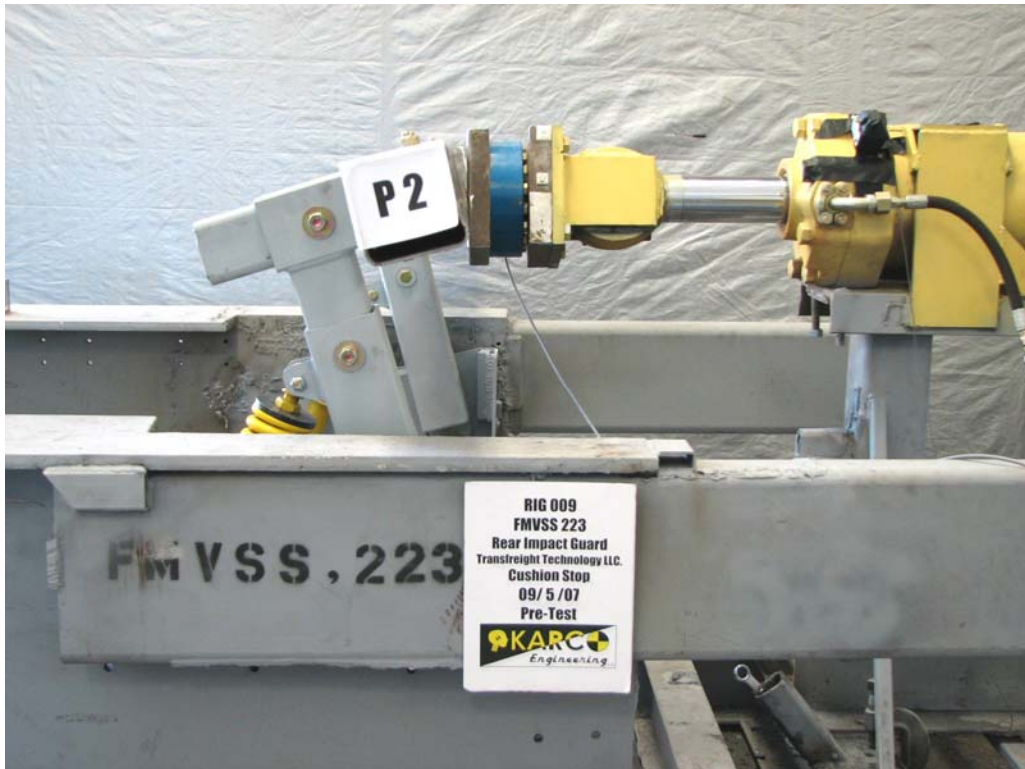
Figure 12. Pre-Test, Location P2, Loaded

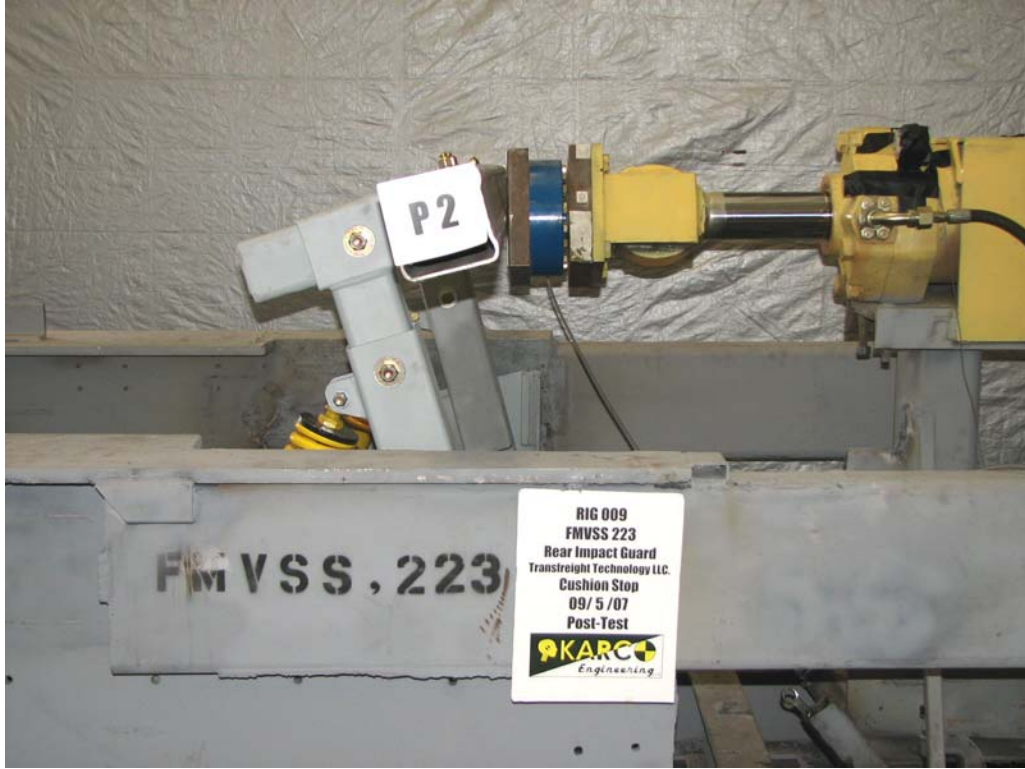
Figure 13. Post-Test, Location P2, Loaded

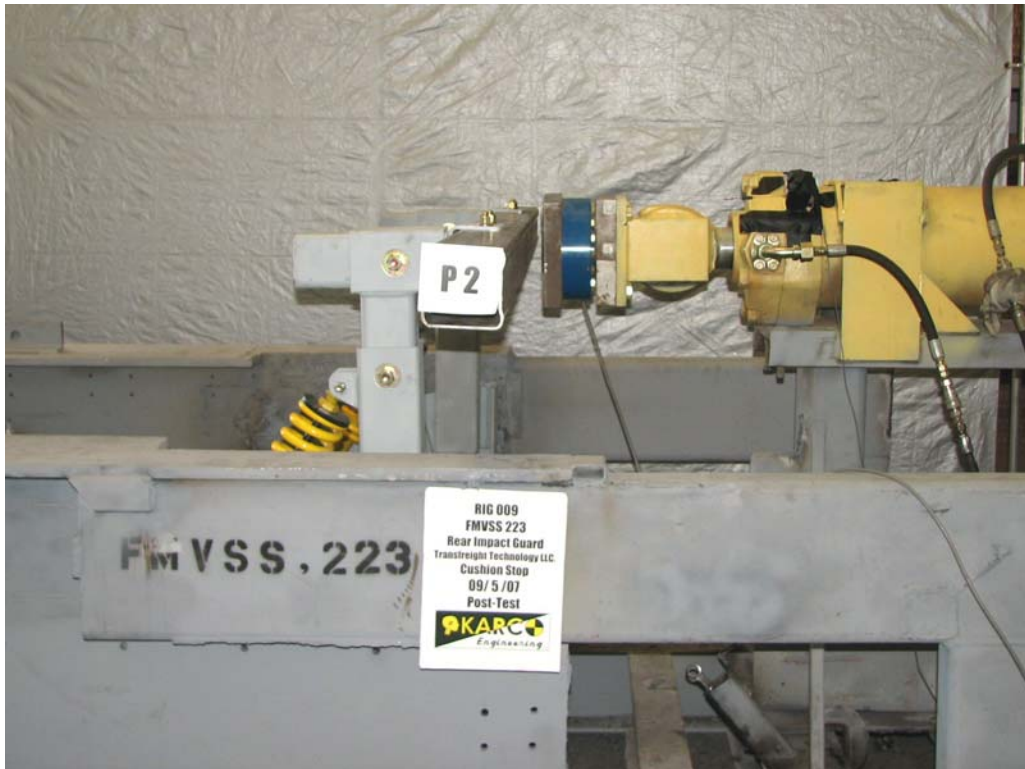
Figure 14. Post-Test, Location P2, Unloaded

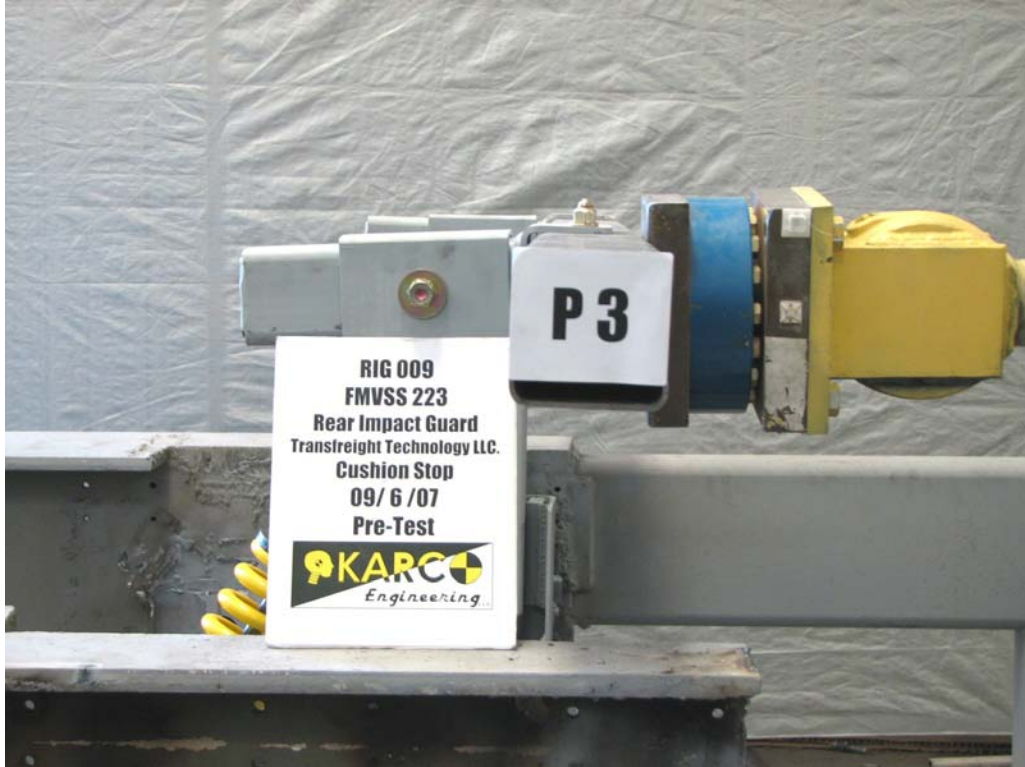
Figure 15. Pre-Test, Location P3, Unloaded

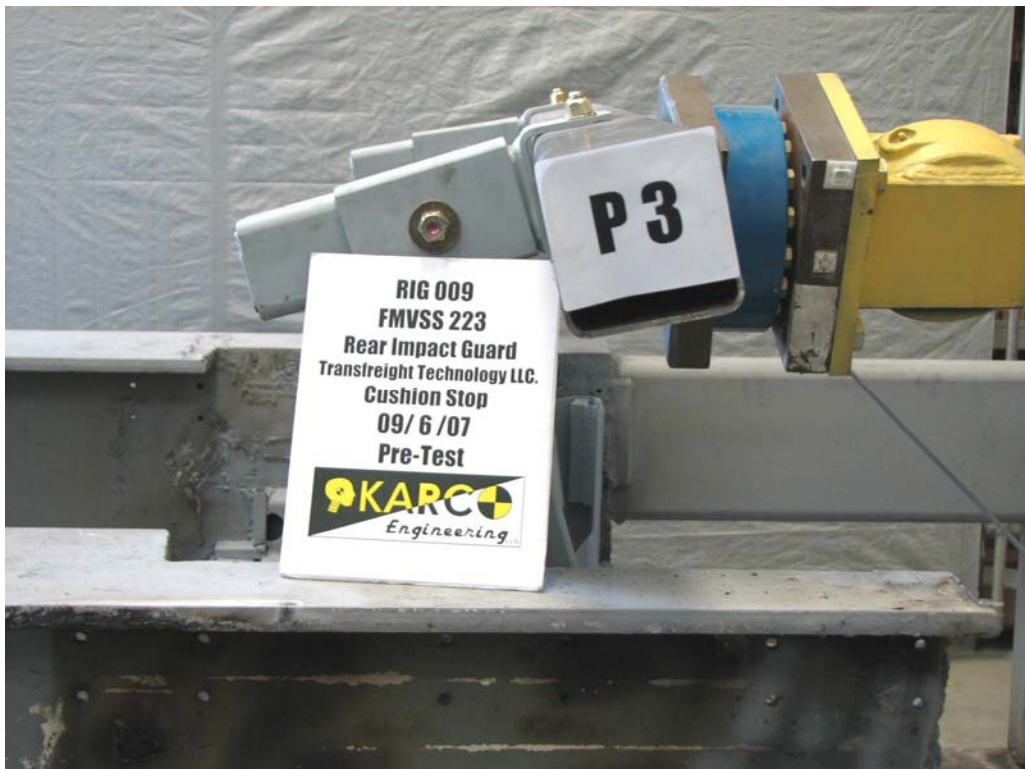
Figure 16. Pre-Test, Location P3, Loaded

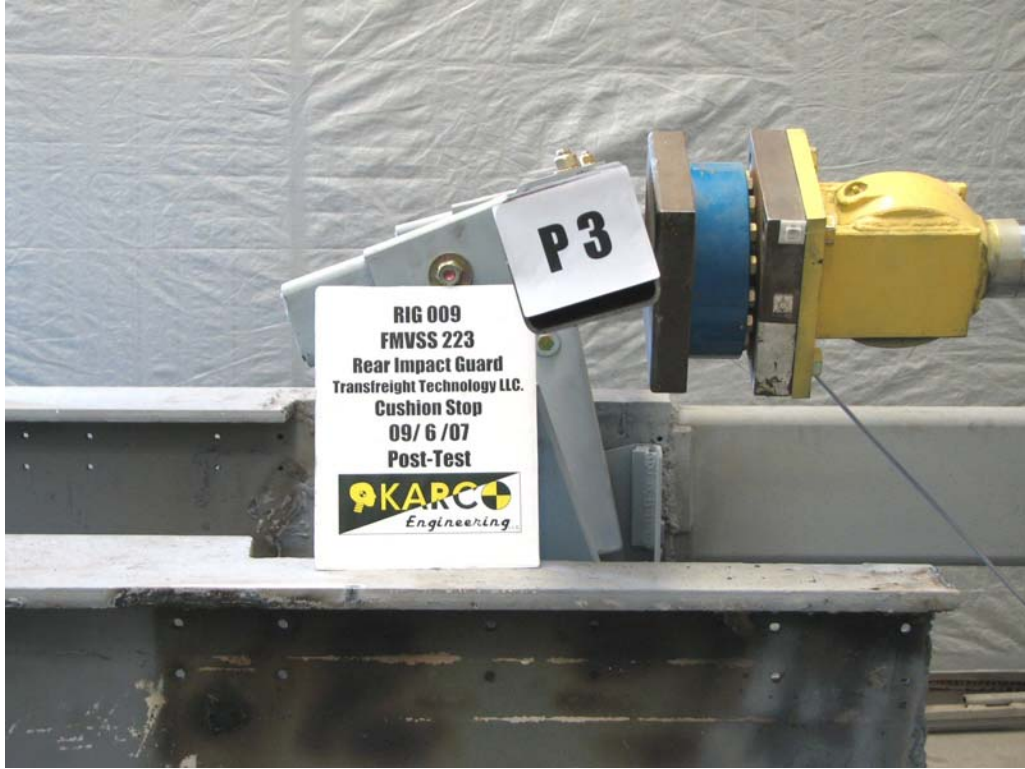
Figure 17. Post-Test, Location P3, Loaded
