REPORT NO. TR-P27004-09-NC

SAFETY COMPLIANCE TESTING FOR FMVSS 223
REAR IMPACT GUARDS

2007 TRANSFREIGHT TECHNOLOGY

NHTSA NO. RIG 009

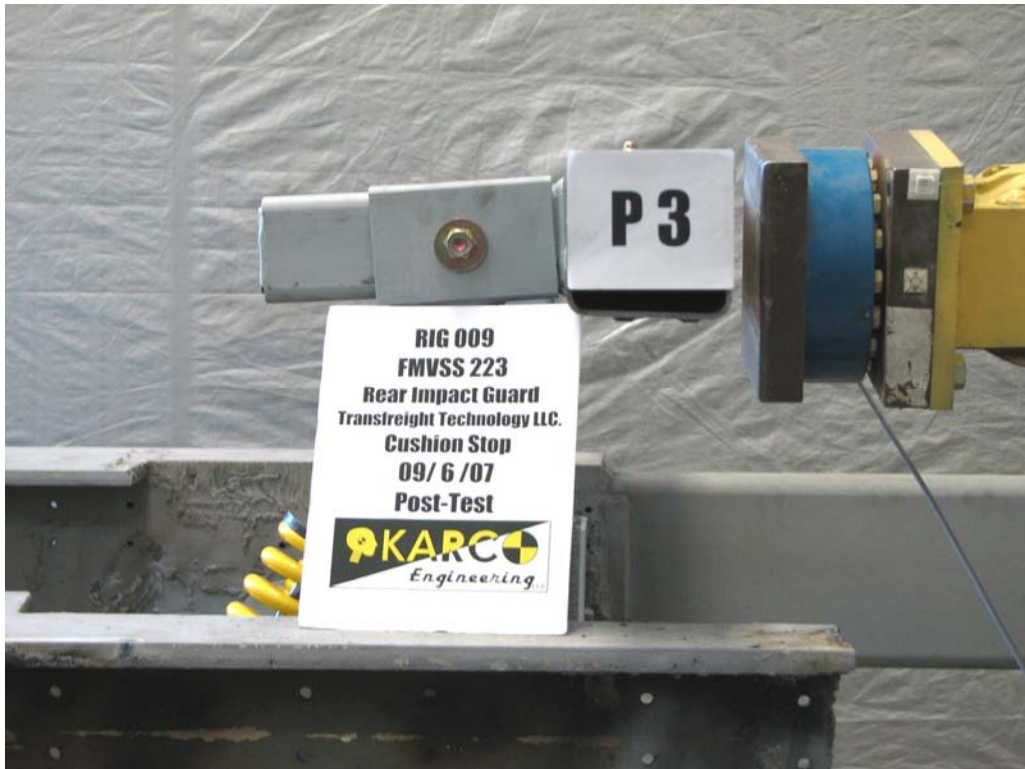
The guard strength test at P3 was performed on September 7, 2007. The force was applied until the rear impact guard displaced 67.6 mm. The maximum load achieved was 101,591 N. The rear impact guard sustained permanent deformation of 34.5 mm. The maximum allowable deformation of 130 mm was not exceeded. The force requirement for this test was met.

Figure 18. Post-Test, Location P3, Unloaded
